Service Bulletin

SB-10056457-6034

SUBJECT: Service Update for Inventory and Customer Vehicles
Hood Latch Striker Weld
Expires with Base Warranty

MODELS: 2015 Cadillac ATS

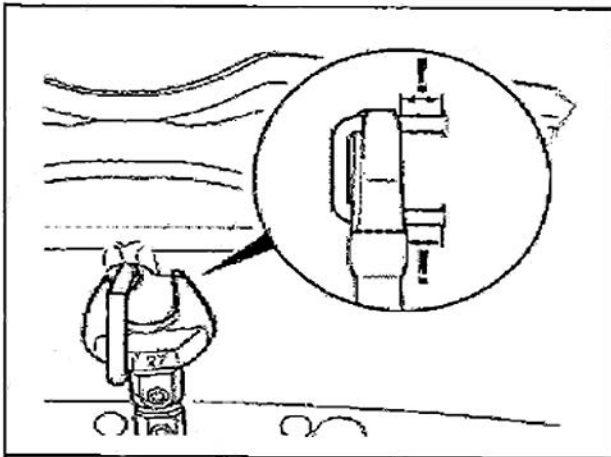
3975743

Note: Use of a 1" crows foot wrench is necessary to check the torque.

2. Position the torque wrench to the lowest position of the hood striker, as shown above.

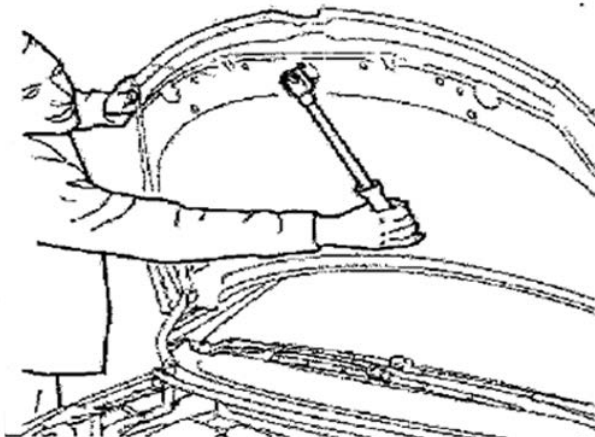
3975744

3. Apply 72 Nm (53 lb ft.) of torque to the striker while holding the hood with the opposite hand.

4. Repeat the same test in the opposite direction.

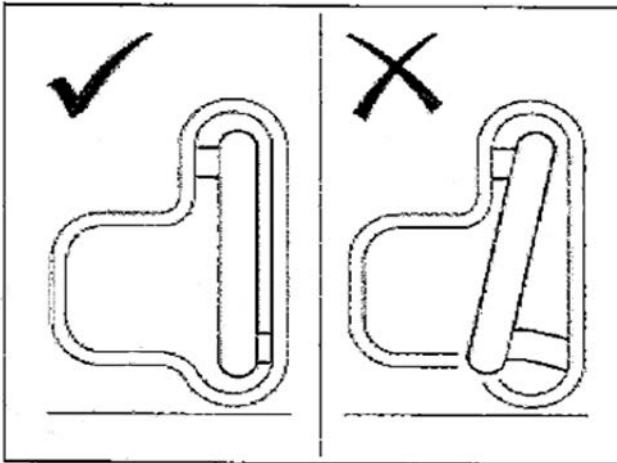
3975749

5. Verify that the striker is not loose or bent, as shown in the example above.

- If the hood striker does NOT show any looseness or bending, no further action is required; just verify the hood closes properly.
- If the hood striker DOES show looseness or bending, continue on to the *Hood Replacement Procedure* below.
