Bulletin No.: PIC6026

Service Bulletin

Subject: Unable To Connect High Voltage Cable To Replacement Accessory DC Power Control Module (APM)

Models: 2011-2013 Chevrolet Volt

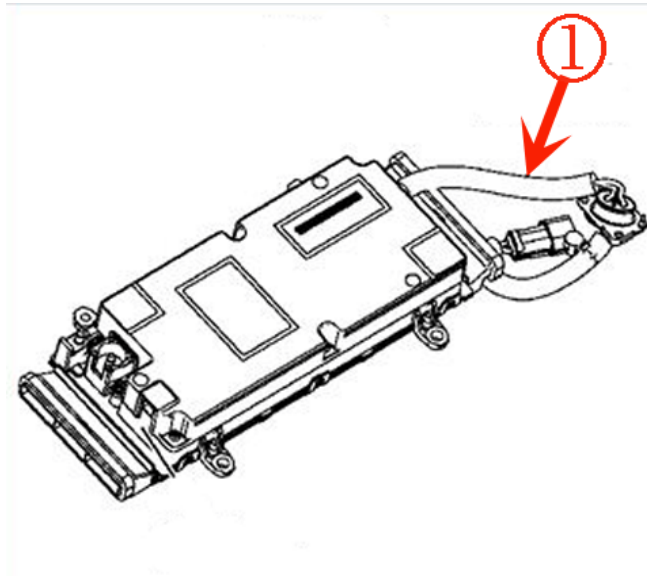
3256768

Certain 2011-2013 Chevrolet Volts were equipped with a first design APM which has a 24 inch orange pigtail attached to the module and there is no high voltage connection right at the module itself (See Photo Below)

If your vehicle has a first design module and you are replacing the APM , an additional jumper harness (GM Part Number 24268507) will need to be installed. An instruction sheet will be provided with the jumper harness kit on how to install the new design module. If the jumper harness instructions were not included with the new part, please contact the Technical Assistance Center for a copy of the instruction sheet.

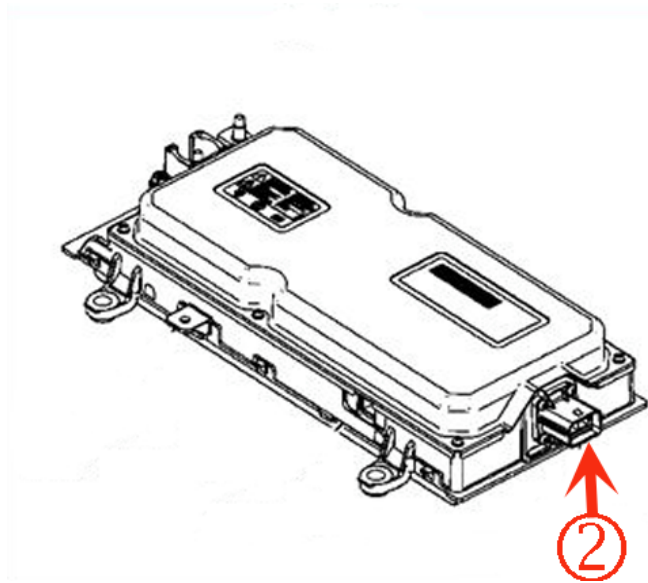
3256773

When replacing the APM with a new service part APM, you will notice that the new part has no pigtail and the high voltage connection is right at the module itself (See Photo Below)
