Program Bulletin

SB-10056460-6943

SUBJECT: Manual Transmission Stuck in Gear

MODELS: 2014 Chevrolet Camaro
Equipped with Manual Transmission (MG9, M10, MM6)

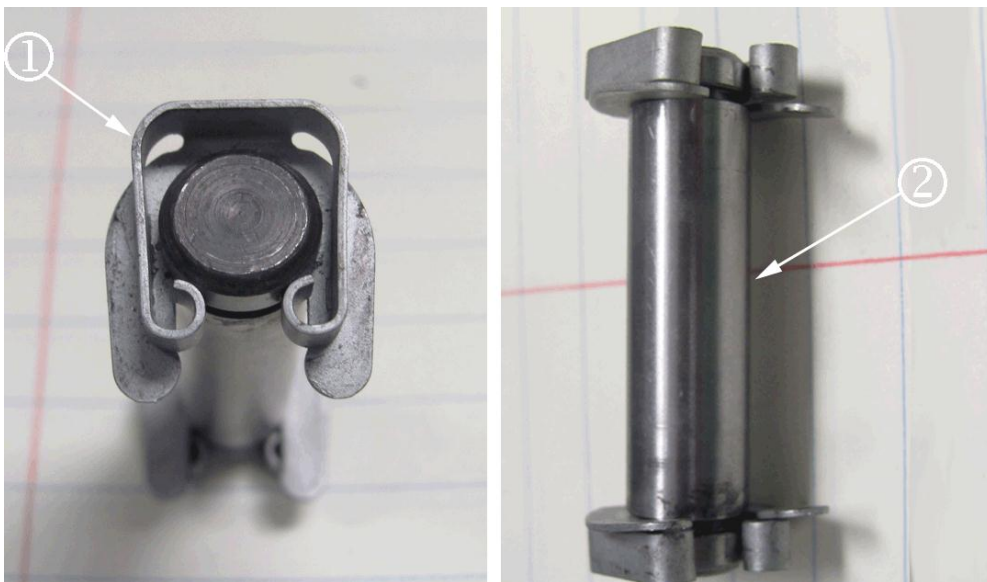
- If the retaining clips (1) and shift linkage pin (2) are present, no further action is required. Lower the vehicle. Refer to *Lifting and Jacking the Vehicle* in SI.

- If the retaining clips (1) or shift linkage pin (2) are NOT present, proceed to step 5.
5. Remove transmission from the vehicle. Refer to *Transmission Replacement* in SI.
