# Program Bulletin

## SB-10056461-1555

## CUSTOMER SATISFACTION PROGRAM

**SUBJECT:** Auxiliary Transmission Cooler Line

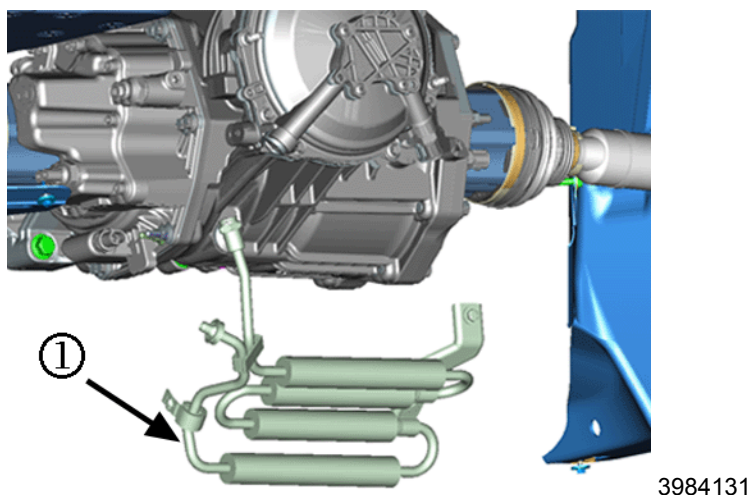
Certain 2014 model year Chevrolet Corvette convertible vehicles have a cooler outlet connector pipe on the auxiliary transmission cooler that may not be properly sealed to its mating connection. The improper seal may cause transmission oil to leak or, under certain conditions, the connector pipe to disconnect from the mating connection. The disconnection of the connector pipe may result in a loss of vehicle propulsion, and leaking transmission oil could cause smoldering if it contacts the heated intake exhaust pipes or mufflers.

1. Remove the transmission fluid auxiliary cooler (1). Refer to *Transmission Fluid Auxiliary Cooler Replacement (MEL / MEP Convertible)* or *(MYC Convertible)* in SI.
2. Install the new transmission fluid auxiliary cooler. Refer to *Transmission Fluid Auxiliary Cooler Replacement (MEL / MEP Convertible)* or *(MYC Convertible)* in SI.
