**SB-10056465-1391**

Bulletin No.: PI1320

## Service Bulletin

**Subject:** Airbag Readiness Light On, DTC B0031 0E and/or B0038 0E Set

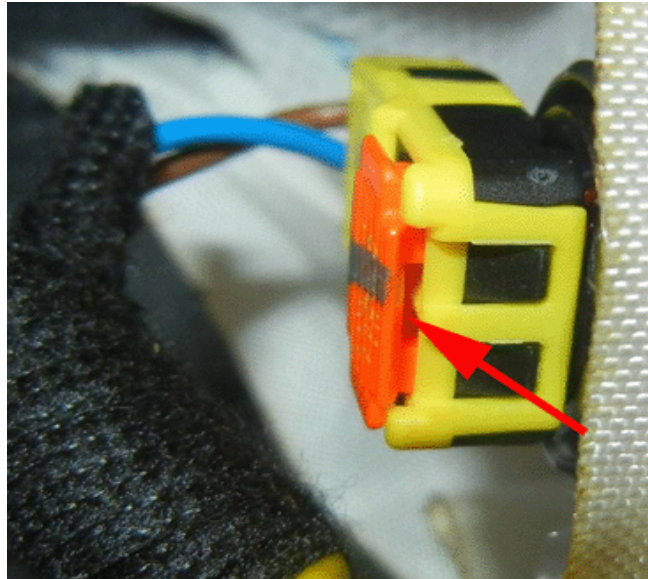
3979599

This condition may be caused by the CPA for the rear seat side airbag connector not being fully seated.

**NOT OK — Visible Gap Between CPA and Connector**

Check the appropriate rear side airbag connector based on the DTC set (see pictures below). If there is a visible gap between the orange CPA and the yellow connector, disconnect and reconnect the connector. Clear the DTCs and recheck.

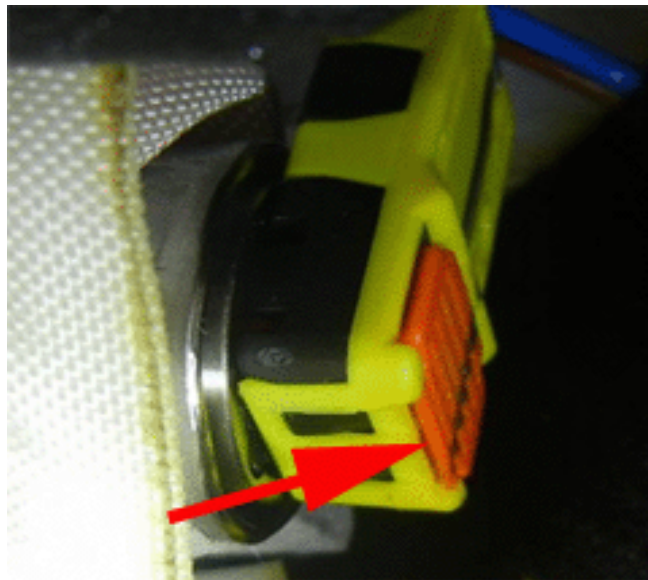
3979604

**OK — No Visible Gap Between CPA and Connector**
