# UPDATE Technical Bulletin

## SB-10056475-8696

### UPDATE – 97AS Driver Seat Harness (NVLW)

Model(s)	Year	Engine Code	Trans. Code
Golf, GTI	2015	All	All

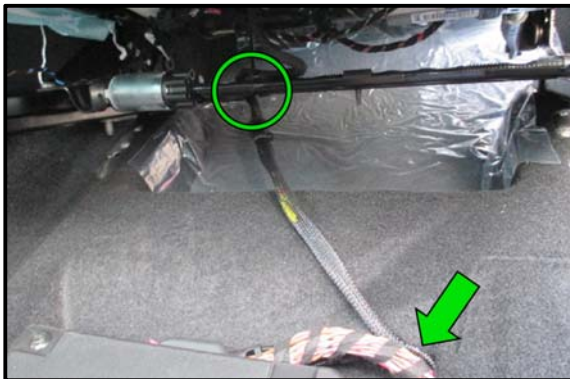
During vehicle production, the driver side power seat harness as it connects to the vehicle may have been incorrectly routed. Damage to the harness for the driver side power seat can occur during operation of the seat adjustments.

⇐ The wiring harness must be routed through the carpet on the inboard side of the access panel <arrow>, then **under** the seat frame as shown <circle>.

- If the harness is routed as pictured, the routing is **correct – Work Complete**
- If the harness is not routed as pictured, the routing is **incorrect**. Inspect the wiring harness for any visible damage.
  - If no damage is found, **Proceed to Section C – Seat Harness Re-routing.**
  - If damage is found, **Proceed to Section D – Seat Harness Replacement.**

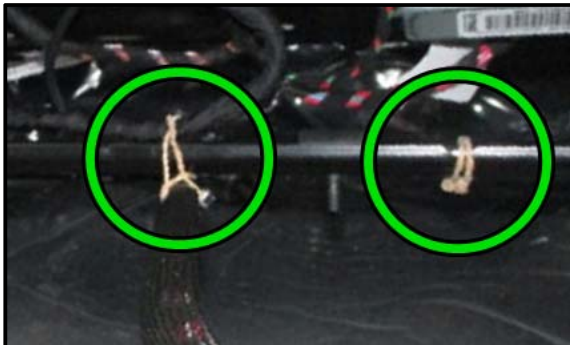
Tip: If rubber bands are found on the wire harness or seat frame <circles>, they can be removed and discarded.
