RECALL CAMPAIGN BULLETIN

NTB14-092

VOLUNTARY EMISSION RECALL CAMPAIGN 2008 – 2010 ROGUE SULEV SPECIFICATION ECM REPROGRAM

APPLIED VEHICLES: 2008 - 2010 Rogue (S35) SULEV specification

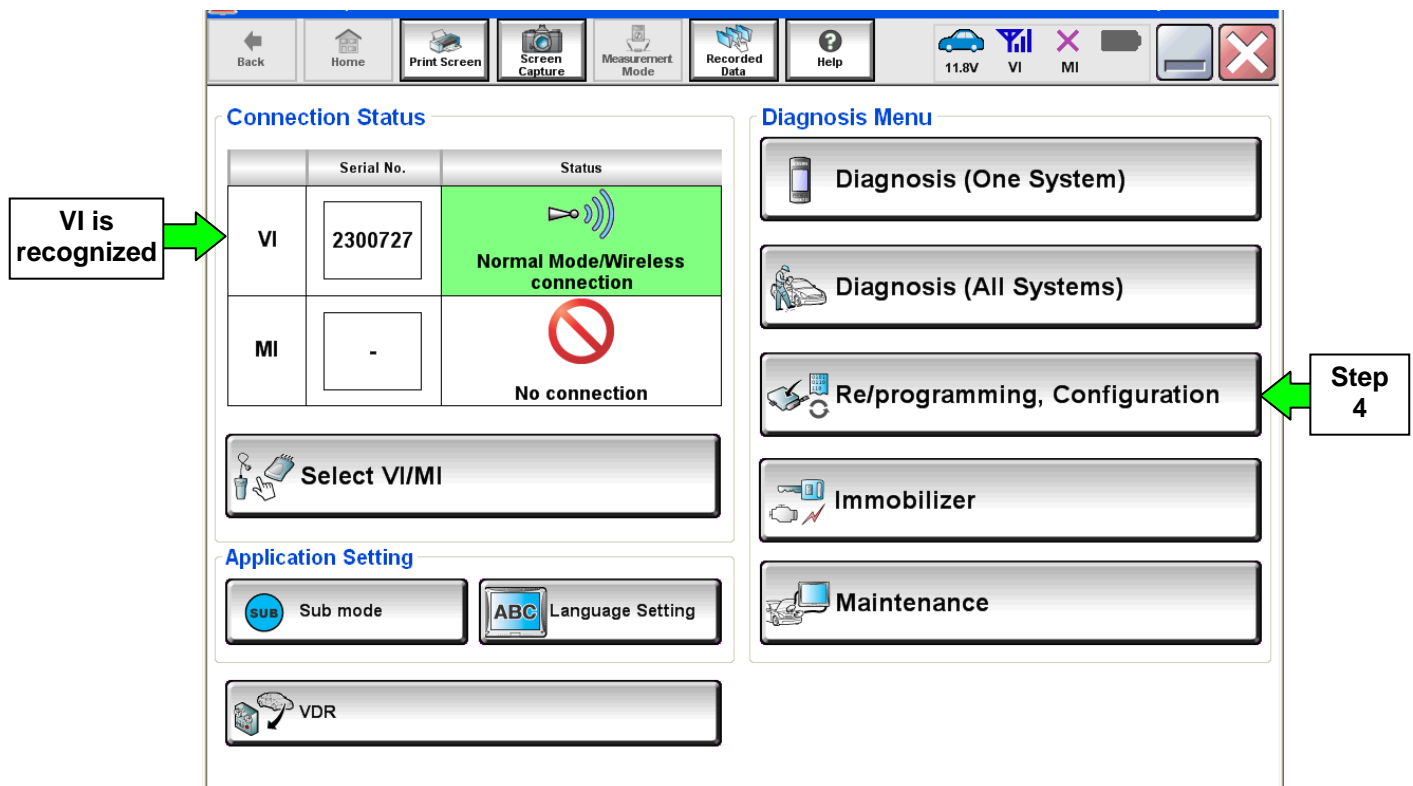
Figure 1

2. Connect the CONSULT PC to the vehicle to begin the reprogramming procedure.
3. Open C-III plus and wait for the plus VI to be recognized.
 - Serial number will display when the plus VI is recognized.
4. Select **Re/programming, Configuration**.

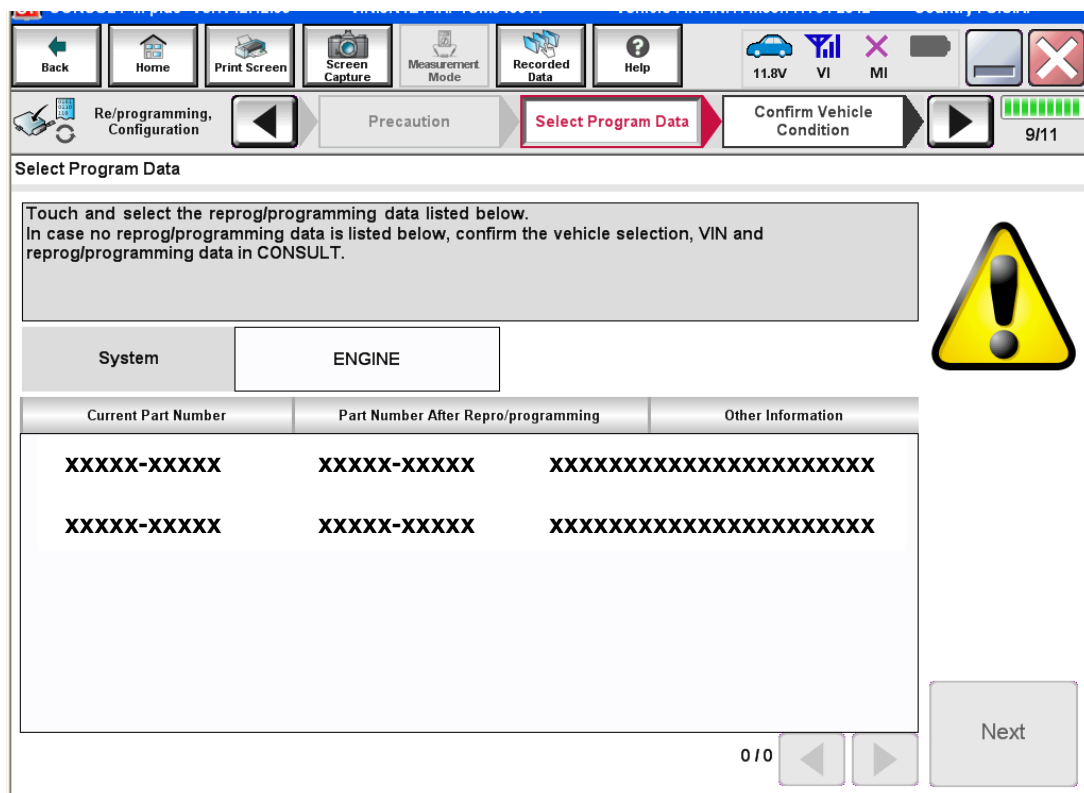
- In some cases, more than one new P/N for reprogramming is available.
 - In that case, the screen in Figure 3 displays.
 - Select and use the reprogramming option that **does not** have the message “Caution! Use ONLY with NTBXX-XXX”.
- If you get this screen and it is blank (no reprogramming listed), it means there is no reprogramming available for this vehicle.

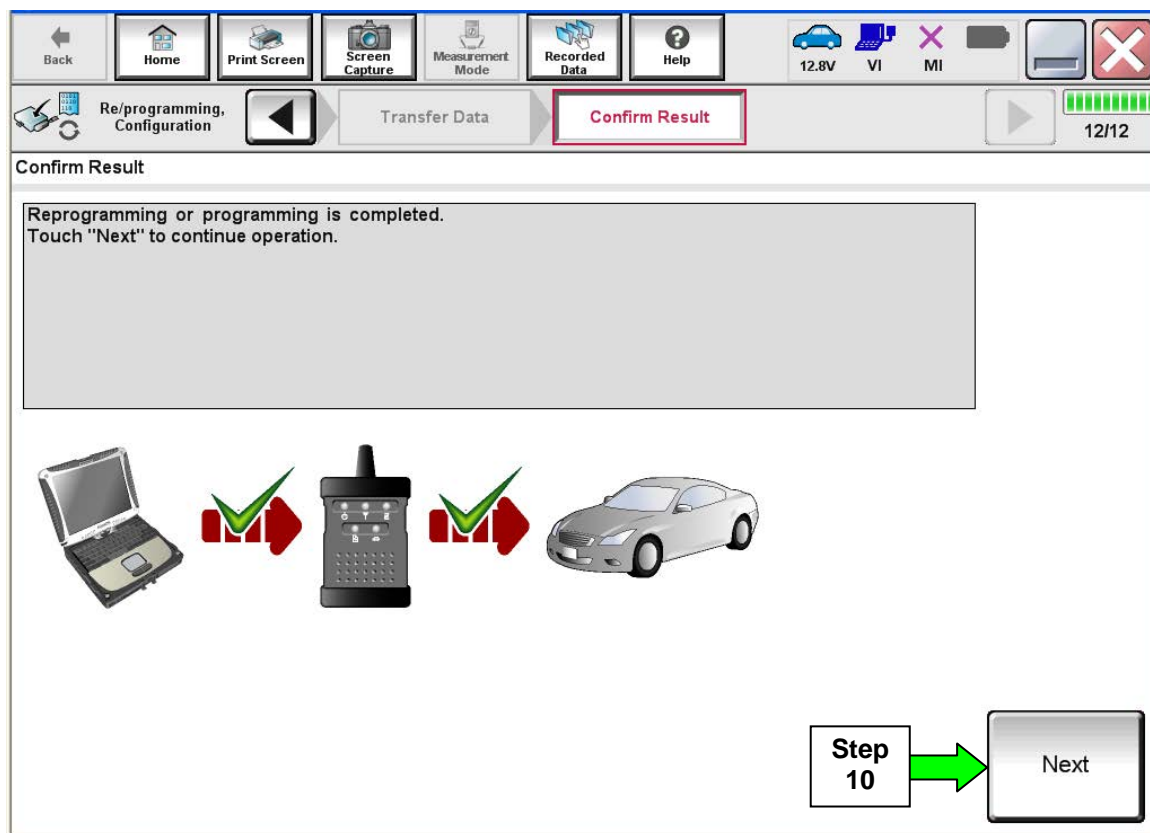
8. When the screen in Figure 4 displays, reprogramming is complete.

NOTE: If the screen in Figure 4 does not display (reprogramming does not complete), refer to the information on the next page.

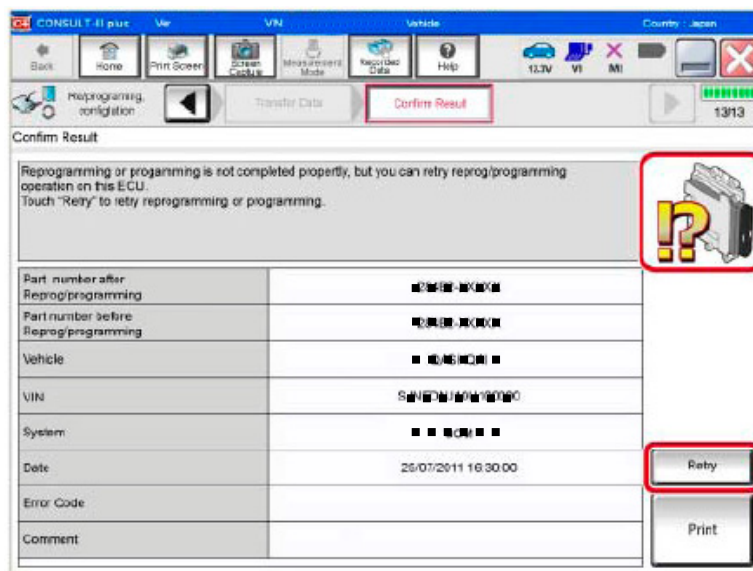
Figure 5

If reprogramming does not complete and the “!” icon displays as shown in Figure 5:

- Check battery voltage (12.0–15.5 V).
- Ignition is ON, engine OFF.
- External Bluetooth® devices are OFF.
- All electrical loads are OFF.
- **Select retry and follow the on screen instructions.**
- “Retry” may not go through on first attempt and can be selected more than once.

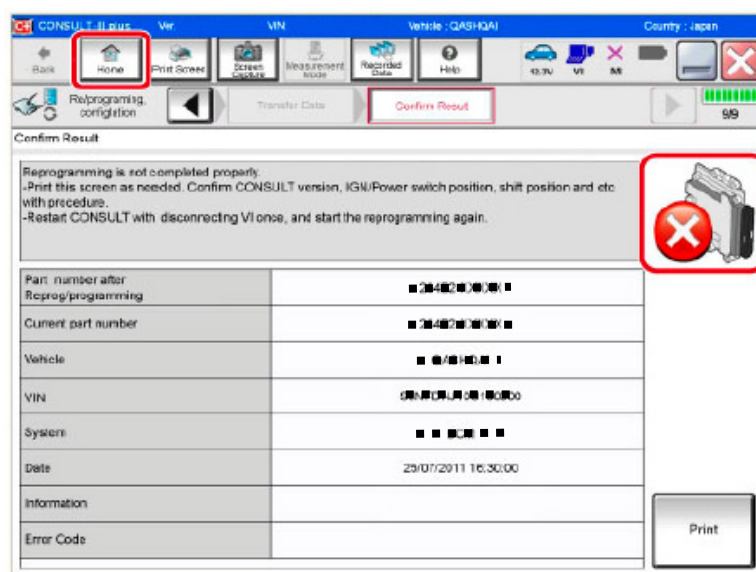
Figure 6

If reprogramming does not complete and the “X” icon displays as shown in Figure 6:

- Check battery voltage (12.0 – 15.5 V).
- CONSULT A/C adapter is plugged in.
- Ignition is ON, engine OFF.
- Transmission is in Park.
- All C-III plus / VI cables are securely connected.
- All C-III plus updates are installed.
- **Select Home, and restart the reprogram procedure from the beginning.**

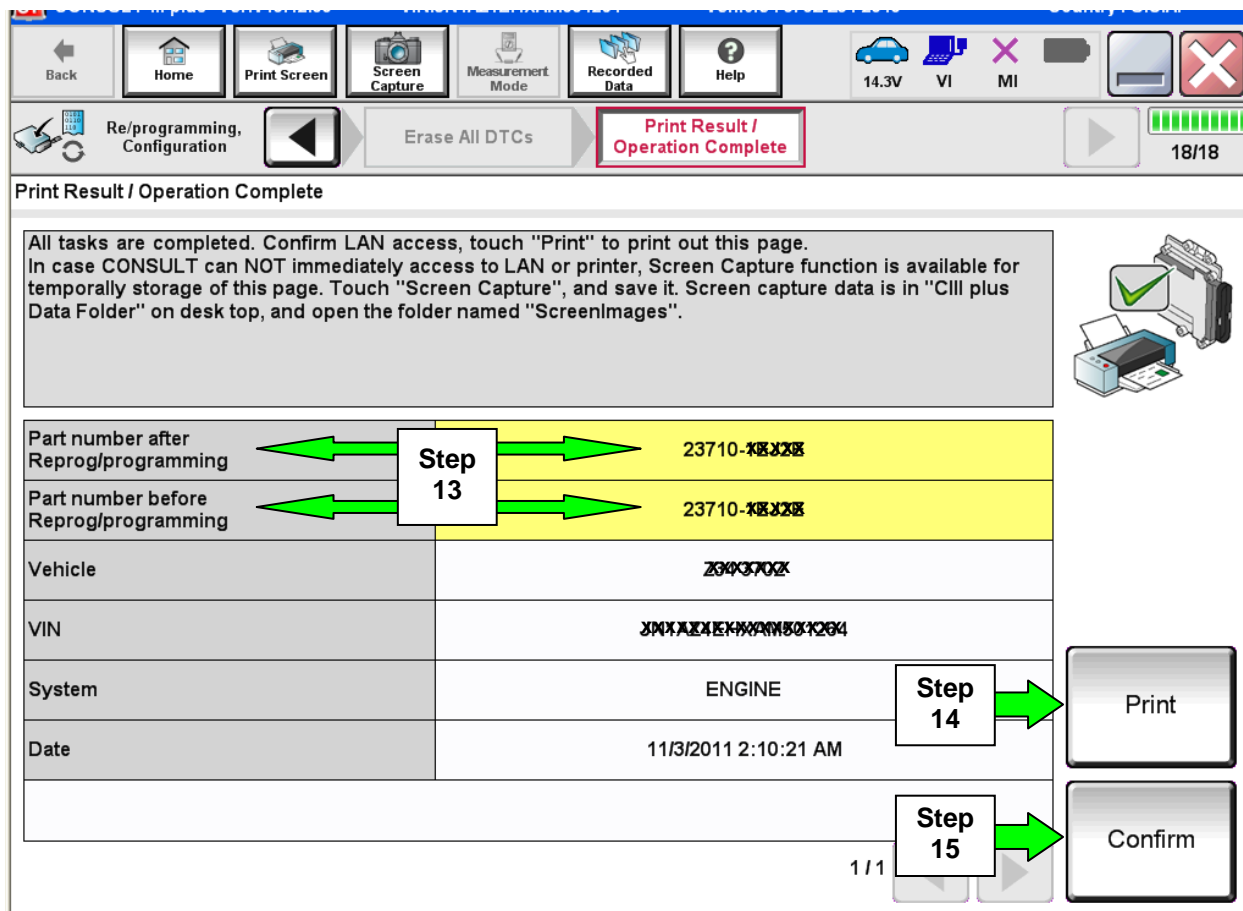
12. When the entire reprogramming process is complete, the screen in Figure 7 will display.
13. Verify the before and after part numbers are different.
14. Print a copy of this screen (Figure 7) and attach it to the repair order for warranty documentation.
15. Select **Confirm**.
