HYUNDAI NEW THINKING. NEW POSSIBILITIES. Technical Service Bulletin	GROUP CAMPAIGN	NUMBER 14-01-029
	DATE JULY, 2014	MODEL(S) GENESIS COUPE (BK)
SUBJECT: ECM UPDATE – 14MY GENESIS COUPE 3.8L DTC P0019/P0024 (SERVICE CAMPAIGN TT7)

SUBJECT: ECM UPDATE – 14MY GENESIS COUPE 3.8L DTC P0019/P0024

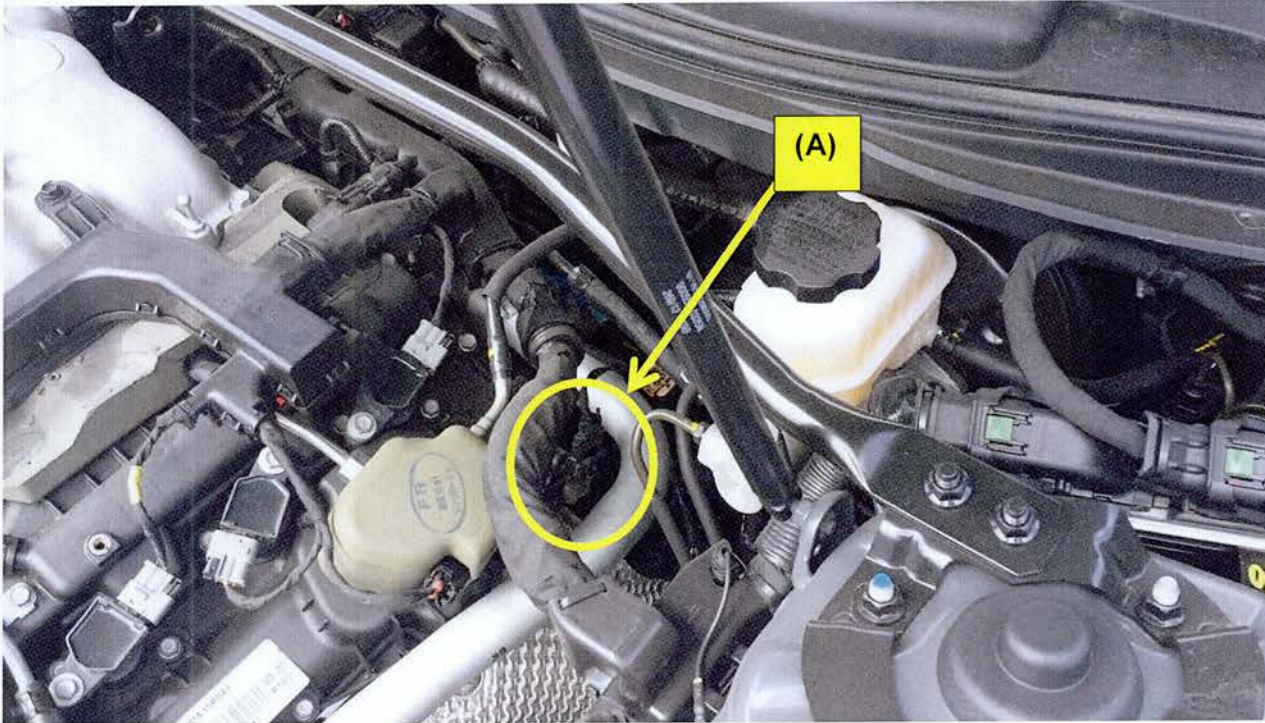
1. Inspect the Bank 2/Exhaust Camshaft sensor **(A)**:

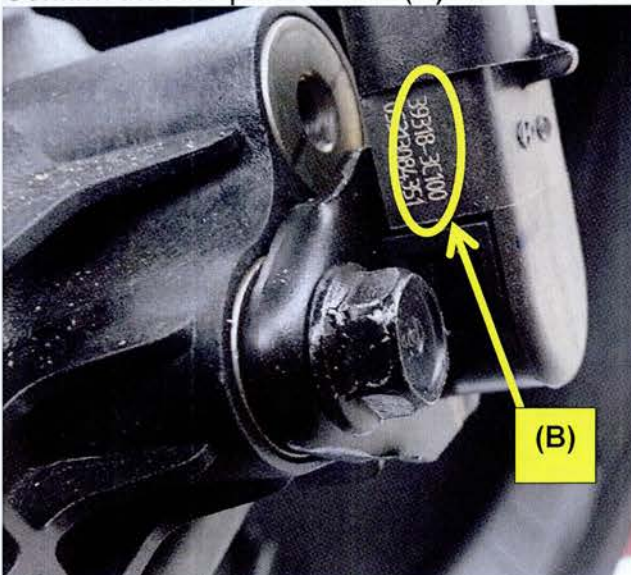
Confirm that the part number **(B)** on the Camshaft sensor is 39318-3C100:
