SB-10056502-5274

HYUNDAI NEW THINKING. NEW POSSIBILITIES. Technical Service Bulletin	GROUP CAMPAIGN	NUMBER 14-01-035
	DATE SEPTEMBER 2014	MODEL(S) EQUUS (VI)
SUBJECT: LDWS UPDATE – MIL ON WITH DTC C1702, C2721 (SERVICE CAMPAIGN TR3)

THIS TSB SUPERSEDES TSB 13-01-047 TO INCLUDE SELECT 2014 EQUUS RETAILED VEHICLES.

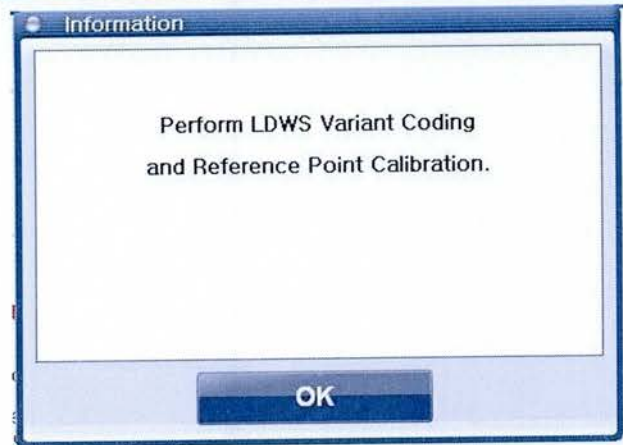
If LDWS Variant Coding and LDWS Reference Point Calibration are needed, the GDS pop up message to the right will be displayed.

In the case that C1702, C2721 DTC are displayed (Previous ROM ID is X90), please perform LDWS Variant Coding and LDWS Reference Point Calibration in sequence in the Vehicle S/W Management function. Steps for the process begin on the next page.
