# SB-10056504-5192

<b>HYUNDAI</b>   NEW THINKING. NEW POSSIBILITIES.	GROUP <b>CAMPAIGN</b>	NUMBER <b>14-01-037</b>
	DATE <b>SEPTEMBER 2014</b>	MODEL(S) <b>SONATA (LF)</b>
<b>Technical Service Bulletin</b>		
SUBJECT: <b>LANE DEPARTURE WARNING SYSTEM (LDWS) SOFTWARE UPDATE (SERVICE CAMPAIGN TU0)</b>

**Description:** This bulletin provides the procedure to update the LDWS module software on certain Sonata (LF) Vehicles. The update corrects an intermittent false illumination of "Front Collision Warning", "Check LDWS", "Check FCW System", and "Check High Beam Assist System" on the instrument cluster.

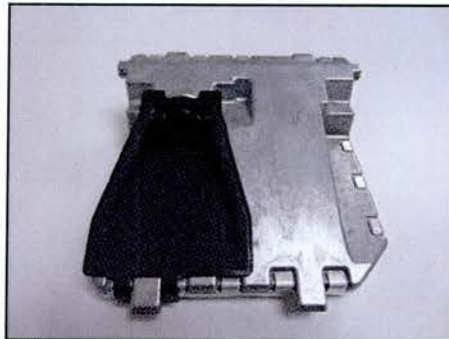
- The following DTC(s) may be stored:
  - ✓ C1672: Steering Angle Signal Invalid LDWS System.
