SB-10056604-8695

SUBJECT: Service Update for Inventory and Customer Vehicles
Power Steering Hose Leak
Expires with Base Warranty

MODELS: 2015 Chevrolet Silverado 2500/3500 HD
2015 GMC Sierra 2500/3500 HD
Served Before September 9, 2014 (Pursuant to Recall Bulletin 14356)

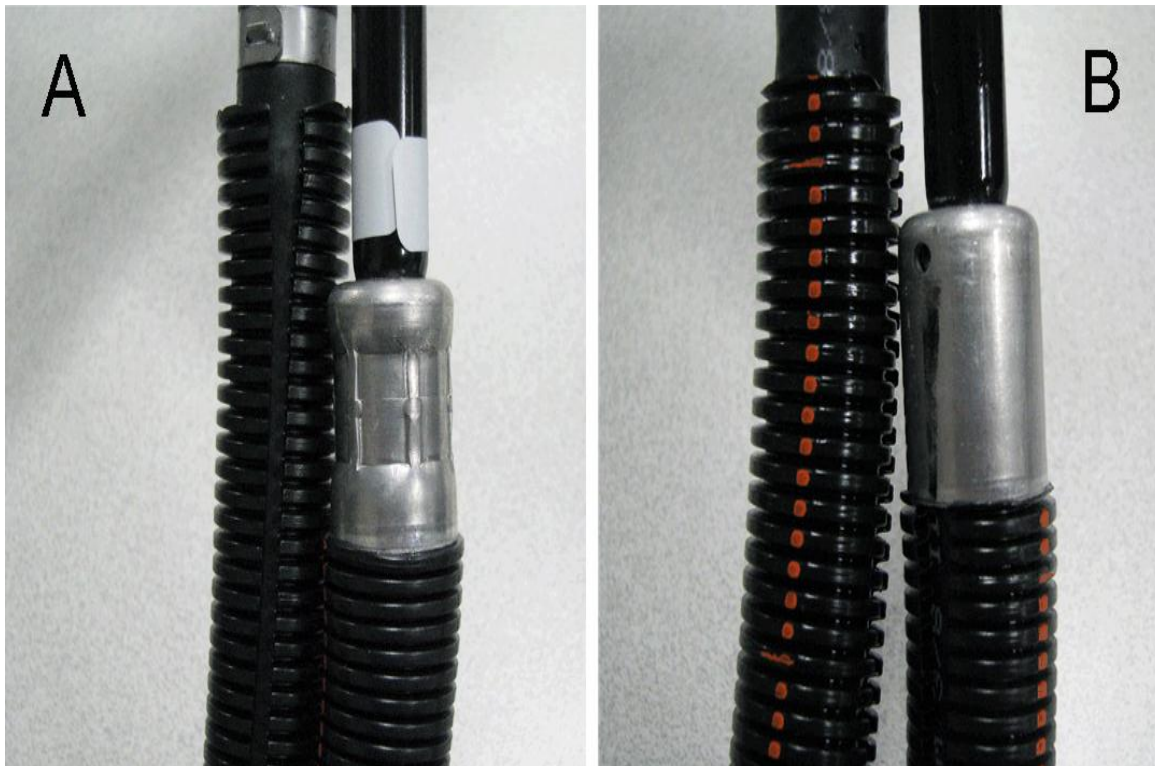
3975435

(A) Crimped ferrule with swedge marks. This is a secure connection on the pipe ferrule. (B) Uncrimped ferrule without swedge marks. This is NOT a secure connection on the pipe ferrule.

- If the power steering hose is missing a ferrule, the crimps are NOT secure or DO NOT show evidence of swedge marks, **replace the power steering fluid cooler**. Refer to *Power Steering Fluid Cooler Replacement (Heavy Duty)* in SI.

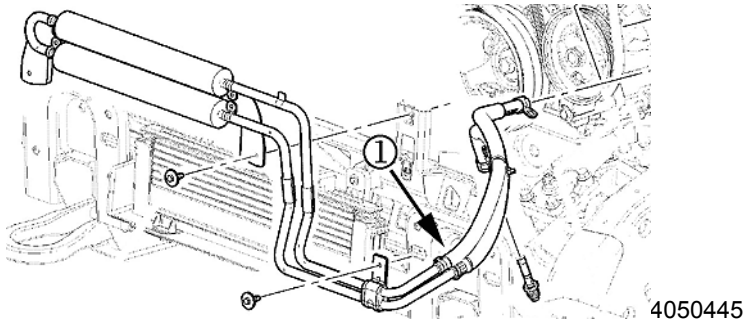
Gas engine shown – Diesel similar

1. Open the hood and locate the section of the power steering cooler lines where the rubber hoses join the metal pipes (1).
2. Verify there is a metal collar (ferrule) on the both rubber hoses where they join the metal pipes.

3. Verify that both ferrules are crimped and display the swedge mark. Pull on the crimped end of the hose to determine if hose crimp is loose (not secure) on the pipe ferrule.

- If the power steering hose crimps are secure and show evidence of swedge marks AND the power steering hose clamps are engaged at both the power steering pump and gear locations, no further action is required. Refer to *Power Steering Fluid Leaks* in SI to diagnose any fluid leaks.
