SB-10056667-1497

1199 Coolant Hose Junction
Models: 1199 Panigale M.Y. '12-'13-'14 (all model versions)
Service Bulletin SVC-14-025

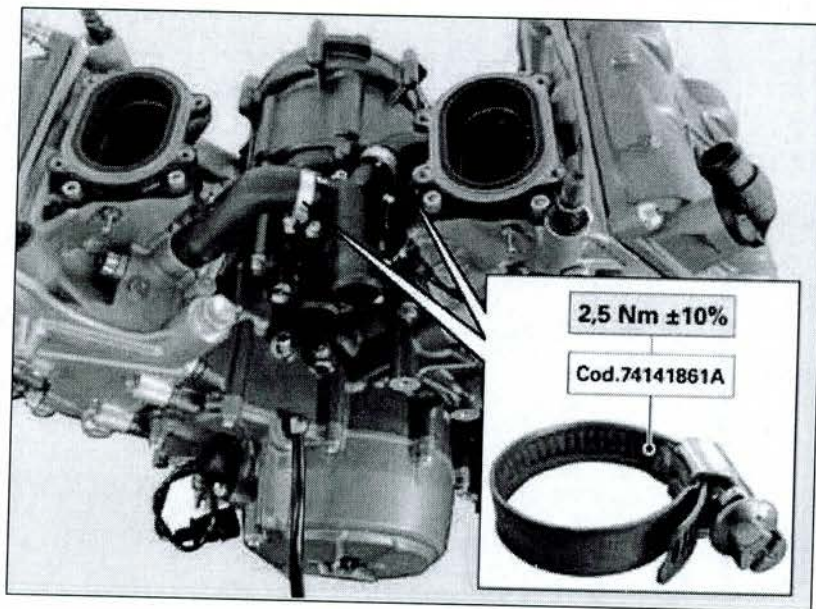
Ducati received a few complaints about slight seepage of coolant from 1199 Panigale coolant hose junctions. We analyzed the claimed parts and found that the seepage is not from hose junction itself, but rather from the hose clamp connections. In instances where this issue is presented, please note that it is not necessary to change the coolant junction assembly; *please proceed as follows.*

Check the type of clamps on the rubber hoses connecting the vertical and horizontal cylinder heads to the plastic junction assembly:

- 1) If you find screw style clamps (NORMA MOD.TORRO 20-32/9 C7, part # 74141861A) installed check the proper tightening to a torque of 2.5 Nm \pm 10%.
- 2) If you find CLIC style clamps, you are required to replace them with clamp part # 74141861A and tighten them to a torque of 2.5 Nm \pm 10%.
