## BMW Motorrad USA

### Service Information Bulletin

**Subject:** Chafing of wiring harness

**Models:** S 1000 RR (K46), S 1000 RR (K46/11), HP4 (K42)

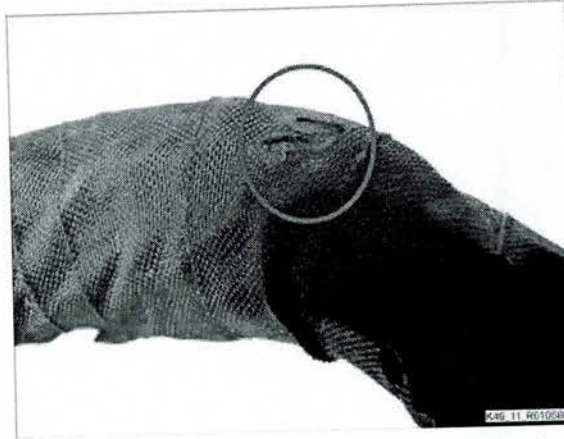
It is very important to examine the wiring harness closely at the points of contact; expose the wiring if necessary. Chafing often affects only very small areas.

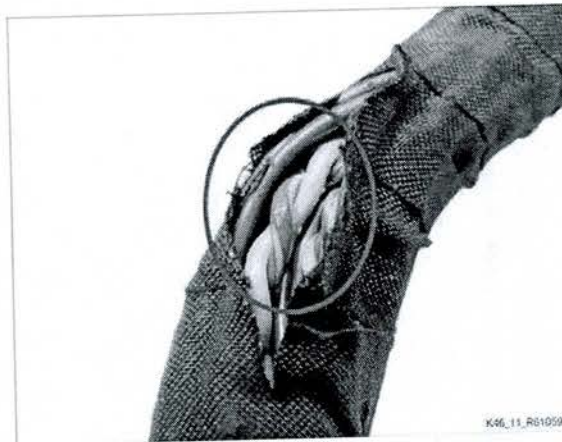
If the cable color cannot be identified at the chafing point: carefully open the wiring harness. If the color of the damaged wire for a component (component identification with the aid of the wiring diagram) and the fault symptom match, the cause has been found. If necessary continue the search for further chafing.

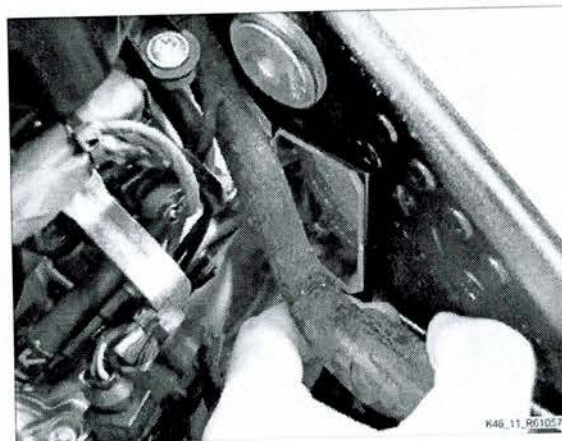
Use a mirror to examine the wiring in awkward locations (e.g. between intake silencer and frame). Remove the intake silencer if necessary for a close examination.

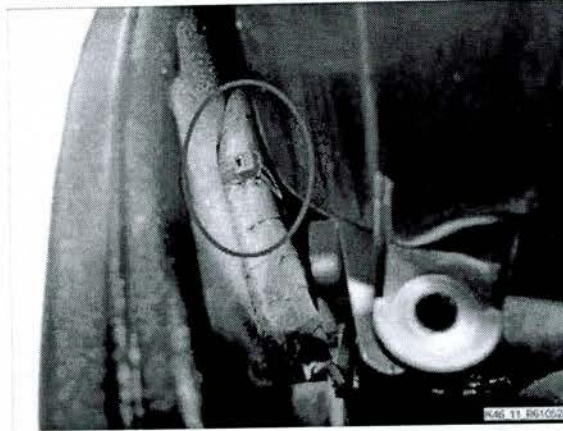
Chafing point on engine wiring harness (left side of vehicle)

In order to prevent the re-occurrence of chafing, wrap the area in question with several layers of genuine reinforced fabric adhesive tape (part number: 83 30 0 402 345) and pad it if necessary - **a length of tire inner tube can work well.**

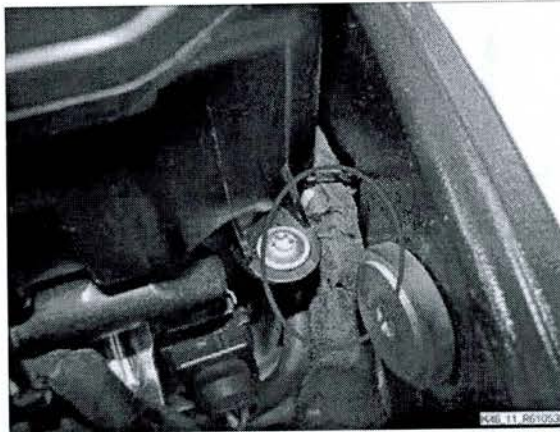
Chafing point on main wiring harness (right side of vehicle)

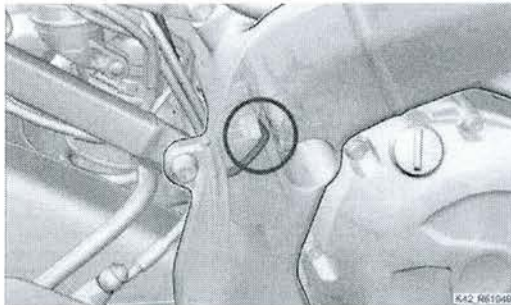
**HP4 (K42): Cable of the rear ride-height sensor chafes against regulator housing**

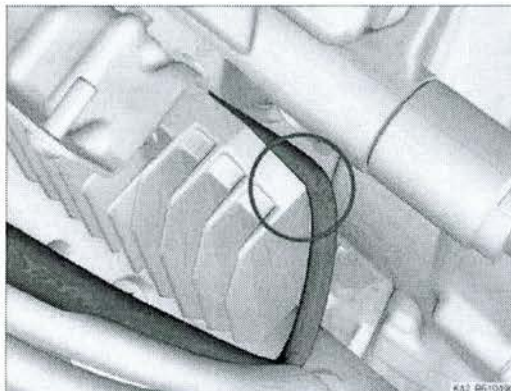
**Close up of HP4 (K42): Cable of the rear ride-height sensor chafes against regulator housing**
