SB-10056697-7185

2013-2014 C-MAX

Some 2013-2014 C-MAX Hybrid and Energi vehicles may experience a concern with a discharged 12 volt battery.

Technical Service Bulletin Title: 2013-2014 C-MAX – Discharged 12 Volt Battery

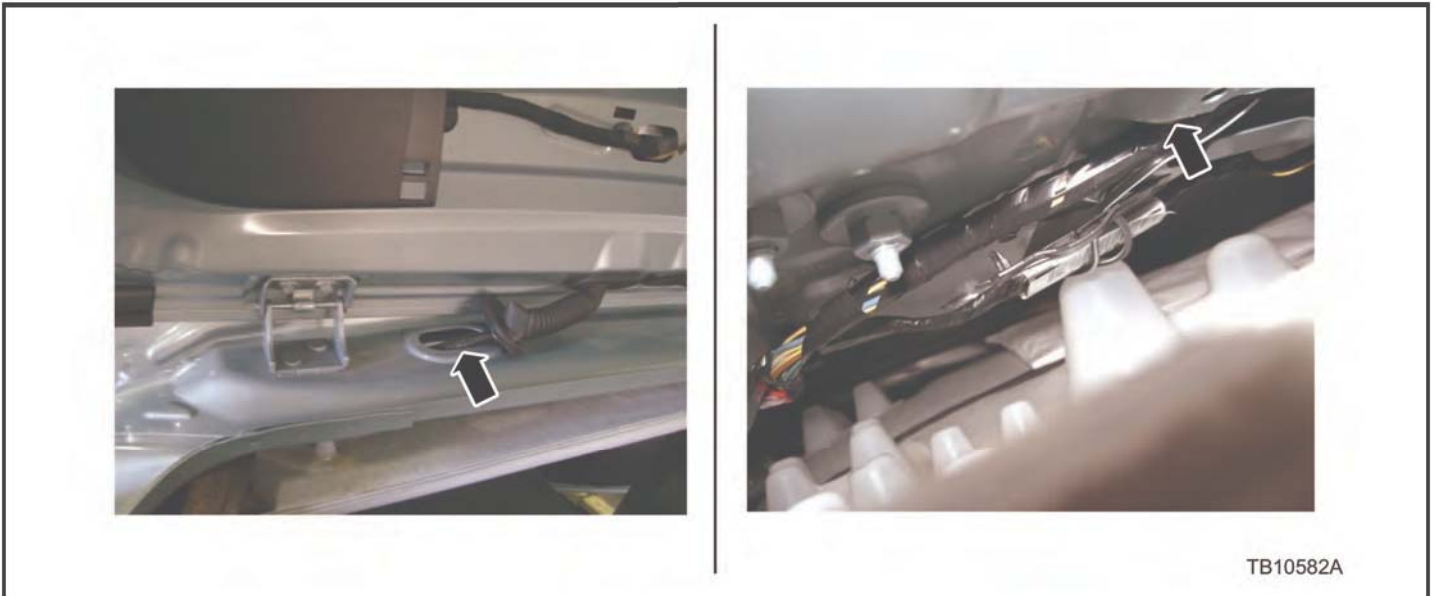
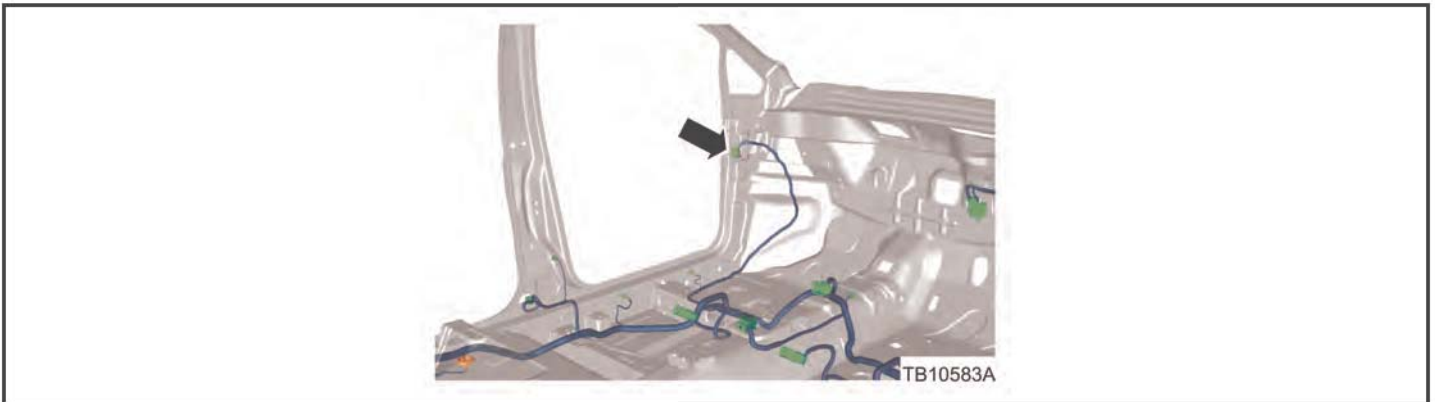
- a. Yes - replace telematics control unit (TCU) Module. Refer to WSM, Section 415-00. Proceed to Step 6.
 - b. No - proceed to Step 6.
6. Is the vehicle built on or before 6/3/2013?
- a. Yes - proceed to Step 7.
 - b. No - proceed to Step 8.
7. Inspect wiring for damage or chafing in rear liftgate area, driver door connector wire harness C339, and front passenger door connector wire harness C340 (Figures 1, 2, 3 and 4). Is damage or chafing present?

- a. Yes - repair circuits as needed. Refer to Wiring Diagram (WD), Section 5-1. After repair, wrap affected area with 3M™ Temflex™ Cotton Friction Tape or equivalent to prevent future concerns. Proceed to step 8.
 - b. No - wrap affected area with 3M™ Temflex™ Cotton Friction Tape or equivalent to prevent future concerns. Proceed to step 8.
8. Print information sheet and provide to customer. Communicate to customer that Ford recommends disconnecting any devices attached to the auxiliary power port, USB port and OBDII port when the vehicle is turned off (e.g. cell phone chargers, USB devices, insurance company snapshot devices, etc.). (Figure 5)
