**SB-10056699-1853****FORD:**

2013-2014 C-MAX

**ISSUE**

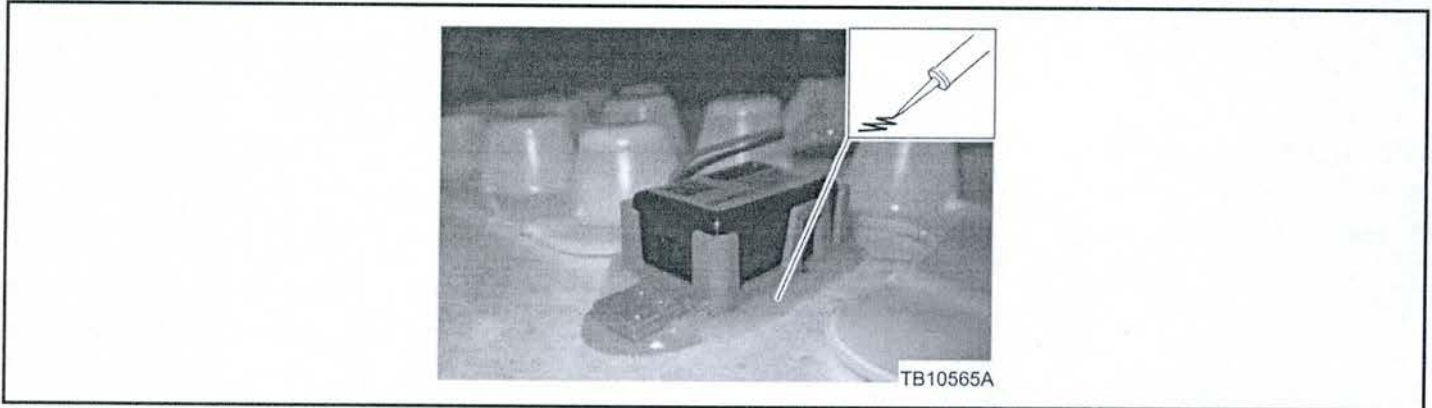
Figure 1 - Article 14-0151

Some 2013-2014 C-MAX Hybrid and C-MAX Energi vehicles may exhibit a loud, low frequency, droning powertrain type noise when the engine is running. The noise can be intermittent and may be heard mostly at specific speeds, RPM ranges, and vehicle loads, such as while driving up a hill or grade. The vehicle is equipped with ANC that uses the vehicle's sound system to cancel out specific low frequency powertrain noises.

- a. Perform an IDS on-demand self-test on the DACMC.
  - b. Did DTC B13F5-01 set in the DACMC?
    - (1) Yes - clear the DTC and reconnect the microphone. Proceed to Step 8.
    - (2) No - disconnect the wire harness from the microphone and reposition the wire harness to connect the harness to the correct microphone, so the fault codes match the microphone position. Clear the DTC. Proceed to Step 8.
8. Fully seal each microphone bezel to the headliner using 3M™ Super-Fast Adhesive. (Figure 1)
