SB-10056716-3131

Door Opens to First Stage While Driving

F15 (X5)

With option 323 (Soft Close)

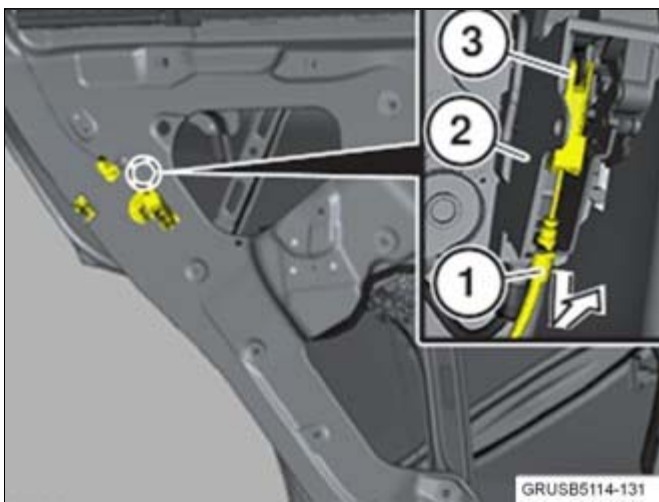
14. Version with Automatic Soft Close:

Disconnect the Bowden cable at the bottom (1) and top (3) from the door lock (2).

Pull the hook for the top cable (3) slightly downwards and hook on the cable. The Bowden cable must be correctly engaged in the locators of the door lock (2) and must be routed without kinking.

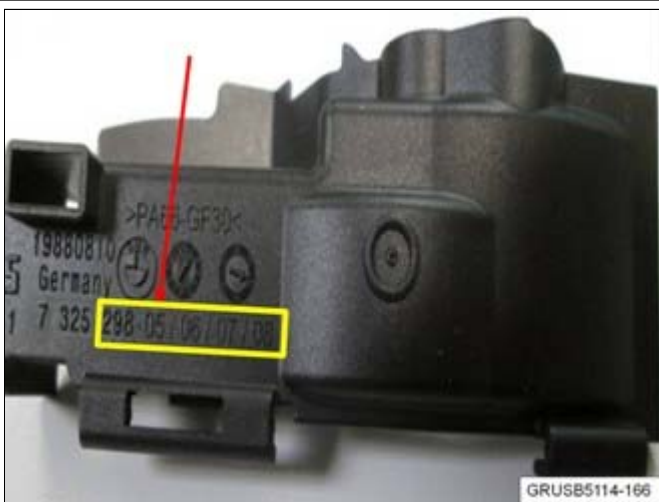
20. Note: The date code on the new Bowden cable cover must be 05 or higher.

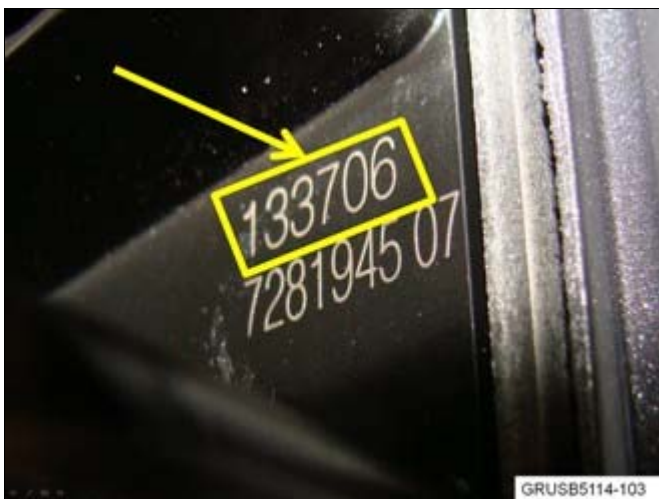
21. The date code on the left side door lock is on the upper line. The number (133706) translates to:

13 = year

37 = week

06 = day

The door lock code shown is a “good” code. The lock does not need to be replaced.

Any door lock with a date code older than 133602 must be replaced.

The repairs performed should be four new modified Bowden cable covers on all four doors and replacement of any door lock with a date code older than 133602. Once confirmed, reinstall all removed parts in reverse order of their removal.
