SI B26 01 14
Driveshaft

August 2014
Technical Service
SB-10056722-1782

Service Action: Inspect Front Driveshaft

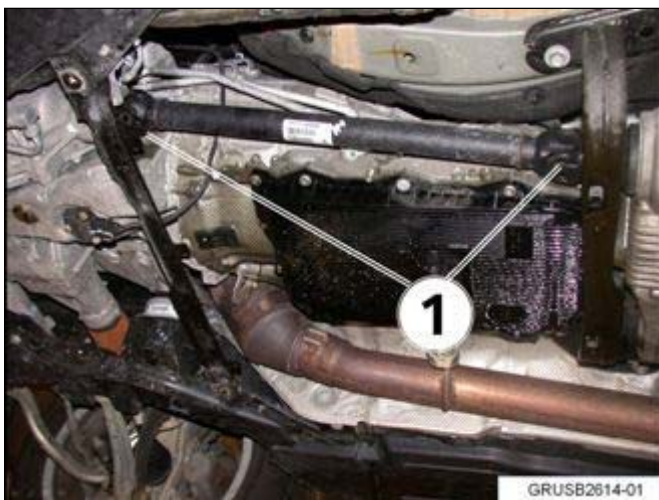
Check the universal joints in the front driveshaft for radial play (1).
Note: The E72 will need to have the reinforcement plate removed to check the driveshaft U-joints. Refer to Repair Instruction 31 10 010, "Removing and installing/replacing reinforcement plate."

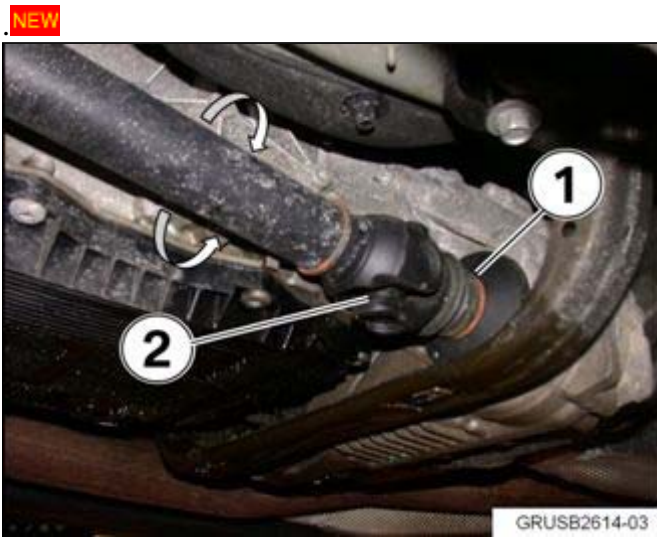
1. Checking the front U-joint:

Hold the input flange (1) on the front differential and check for radial play in the U-joint (2). There should be no excessive play.

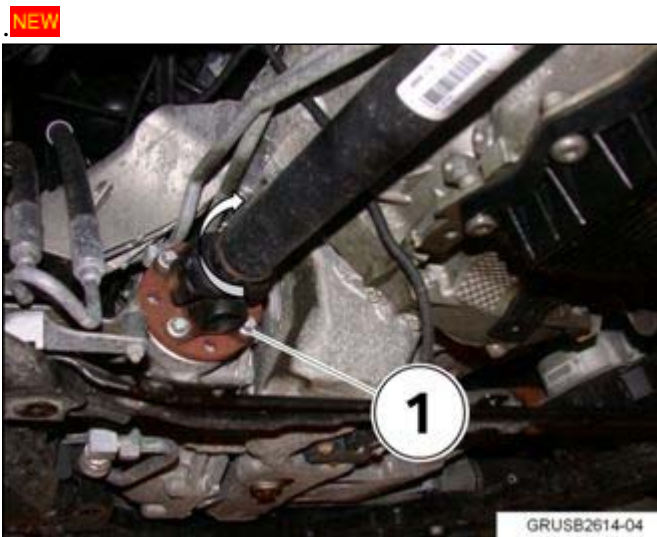
2. Checking the rear U-joint:

Hold the output flange (1) on the transfer case and check for radial play in the U-joint (2). There should be no excessive play.

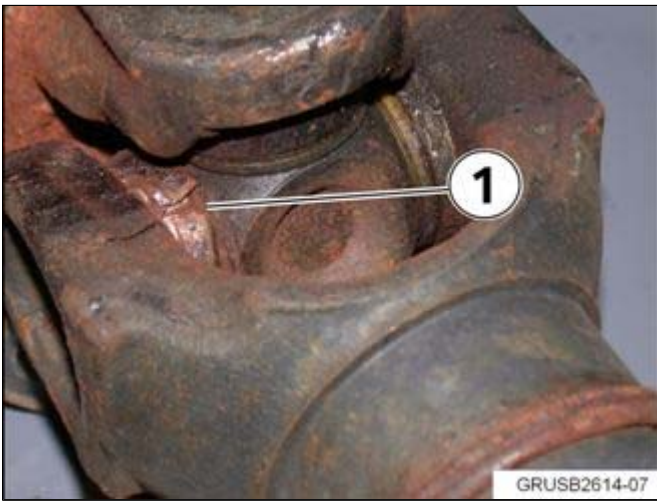
1. **NEW** There should be no cracking or damage at the bearing seals (1).

NEW If any of the above conditions are present, replace the driveshaft. Refer to Repair Instruction 26 20 000, "Removing and installing front propeller shaft as of 4/2010."

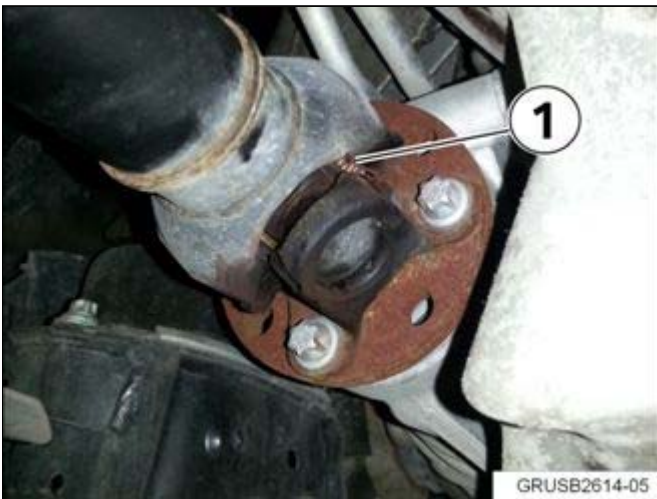
2. **NEW** There should be no exposed needle bearings (1).

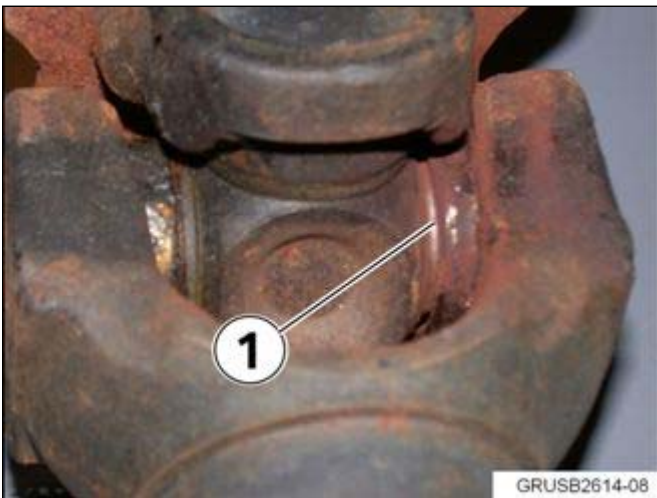
3. **NEW** There should be no excessive rust at the bearing seals (1). Note: There will be rust buildup on the driveshaft and mounting flange on some driveshafts. This rust is normal. Only excessive rust on the bearing seals indicates the seal may fail.

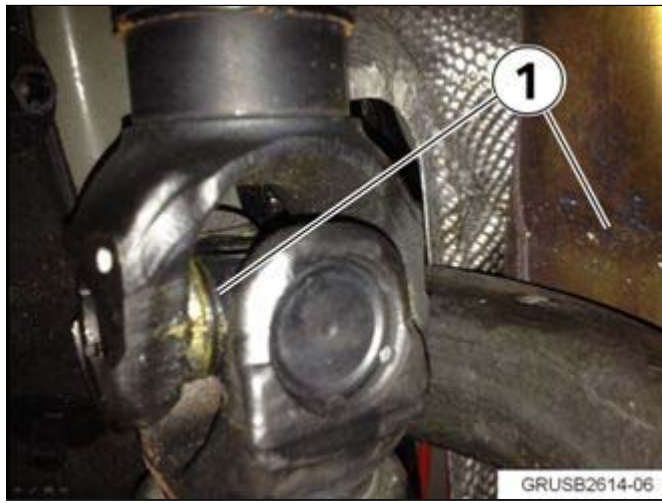
4. **NEW** Also check for excessive grease marks on the surfaces of surrounding components around

the U-joints and for excessive grease released out of the bearing seals (1).
