MIN – 14119
03 September 2014

SB-10056783-9037

Subject:
ProStar® Inoperative Engine Brake

Models Involved:
ProStar®

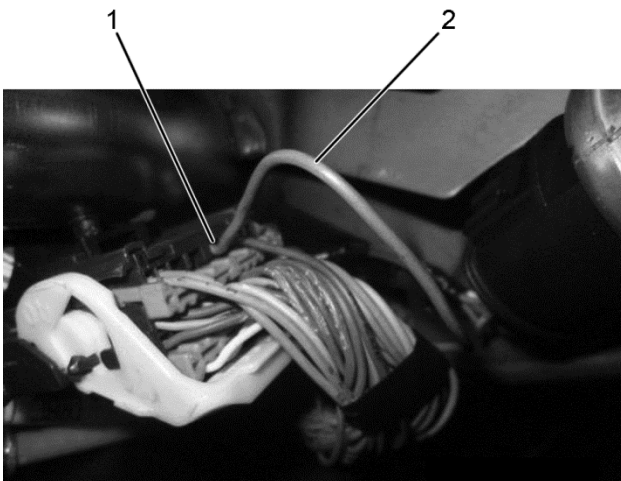
Figure 1. Connector 1800.

1. Cavity D4
2. Wire harness

12. Unlock connector 1800.

13. Install / populate newly built harness end (Figure 1, Item 2) with Packard terminal into cavity D4 (Figure 1, Item 1).

14. Lock connector 1800.

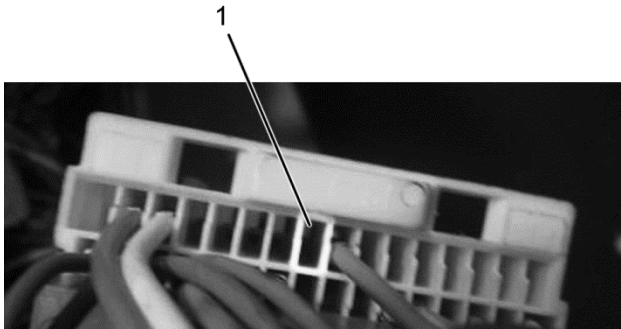
Figure 2. Connector 1602.

1. Cavity F8

15. Gain access to connector 1602 near body controller.

16. Unlock connector 1602.

17. Install / populate newly built harness end (Figure 1, Item 2) with female terminal into cavity F8 (Figure 2, Item 1).

18. Lock connector 1602.
