MIN – 14120

SB-10056784-5379

Starter Cable Routing Inspection

SFA 7600 WorkStar® with Navistar® N13 (EPA 10) with SCR engines

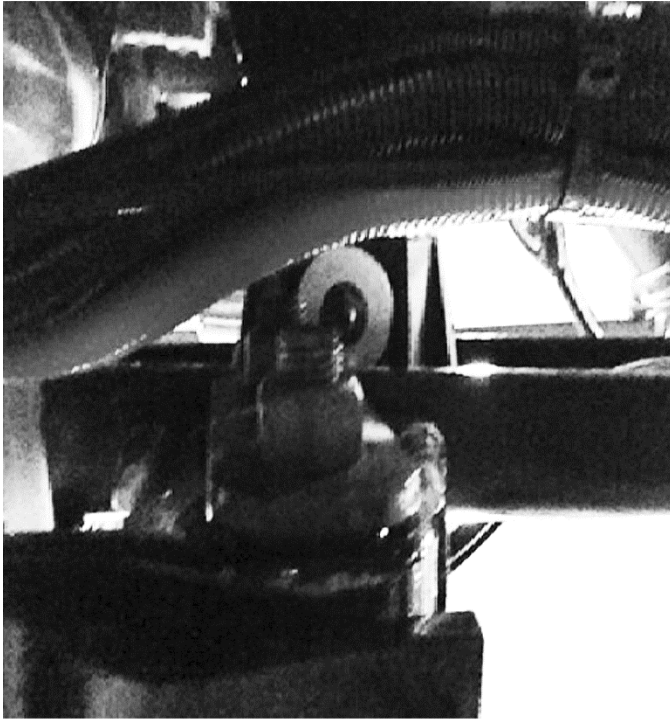
Figure 1. Starter Cable Routing.

This procedure is for inspecting the starter cable routing on SFA 7600 WorkStar® with Navistar® N13 (EPA 10) with SCR engines.

4. Verify cable strap is pulled tight, providing proper routing as shown in Figures 1 and 2.
 - a. There should be a minimum of ½-in clearance between cables and other components on vehicle.
 - b. If there is less than a ½-in clearance, cut and remove cable straps, adjust cables, and install new cable straps.
5. Close and latch hood.
6. Remove wheel chocks.
