### **Subject: Meritor WABCO OnGuard System**

**Models Affected:** Specific Freightliner Cascadia vehicles manufactured November 13, 2012, through March 13, 2014, with a Meritor WABCO OnGuard system.

Daimler Trucks North America LLC, on behalf of its Freightliner Trucks Division, is initiating Field Service Campaign SF499A-H to modify the vehicles mentioned above.

June 2014  
SF499A-H

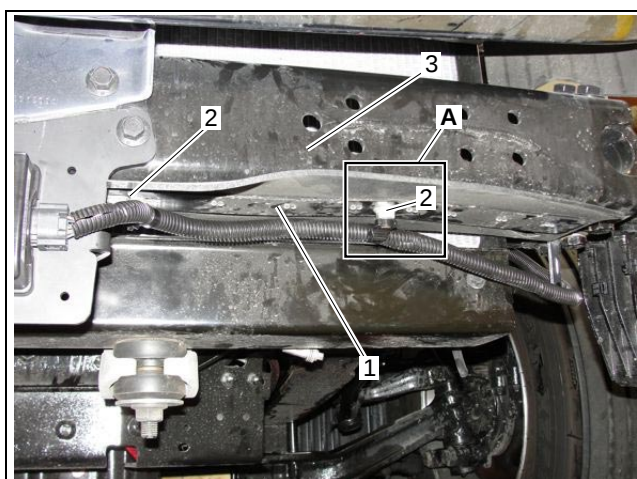
**Fig. 9, OnGuard Harness Routed Under the Forward Crossmember**

A. The stud-mounted tie straps attach to the threads of the air baffle bolts.

1. Remove the bumper.
2. Locate the radiator air baffle on the driver's side of the vehicle, and remove the two mounting bolts nearest to the OnGuard mounting bracket. See **Fig. 9**. Flip the orientation of the bolts and install them so that the threads are facing down. Tighten the nuts securely.
3. Position a stud-mount tie strap (23-12115-001) on each bolt thread, then secure the harness. See **Fig. 9**.
4. Install the L-bracket.
  - 4.1 Remove the center mounting bolt from the driver's-side frame rail extension. See **Fig. 10**.
  - 4.2 Position the L-bracket (23-09130-007) on the frame rail extension at a 45° angle so that the "L" is facing away from the vehicle, then install the bolt.

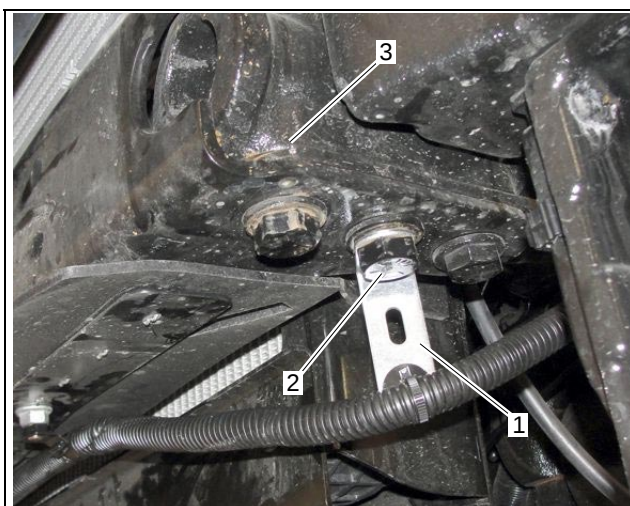
**Fig. 10, Harness Secured to the L-Bracket**

**IMPORTANT:** Make sure that the harness is oriented away from the OnGuard mounting bracket. The harness will be chafed and damaged if it contacts the bracket.

4.4 Secure the harness to the L-bracket with a push-on tie strap (23-13481-000). See **Fig. 10**.

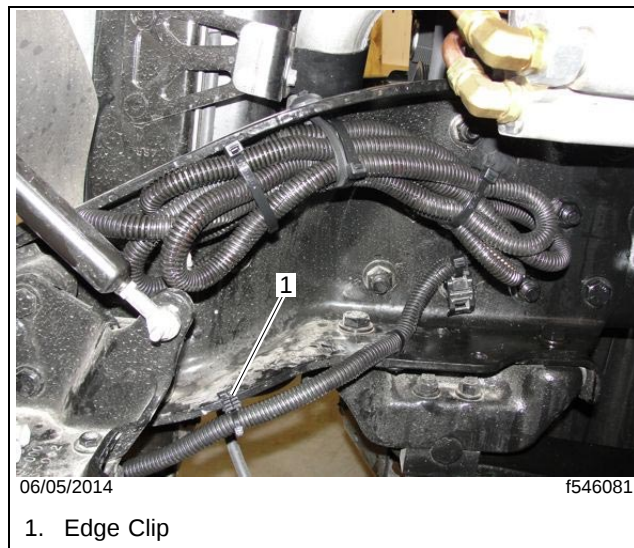
**Fig. 11, Excess Harness**

**NOTE:** Harness configuration varies, and may branch off of the headlight and fog light harnesses. Follow the forward radar harness from the radar mount location back to the main commodity harness on the inboard side of the frame rail. The forward radar harness should be routed underneath the forward closing crossmember and outboard on the driver's side, then over the top of the frame rail extension and through the front frame bracket pass-through hole. Make sure the harness is not positioned in a manner that will cause it to rub or become pinched.

**NOTE:** Use an edge clip (23-13477-200), if necessary, to keep the harness away from the frame rail extension. See **Fig. 11**.

5. Bundle any excess harness in the engine bay, and tuck it tightly against the frame rail. Secure the harness with button-head tie straps (23-12069-001) so that it does not come in contact with the steering column or any other moving parts. See **Fig. 11**.
