### SB-10056796-6927

# Product Service Bulletin

**MODEL:** CONVENTIONAL, FS65, EF, EFX, ER/HD, HDX

**SUBJECT:** FLOOR CROSS TUBE CRACK REPAIR

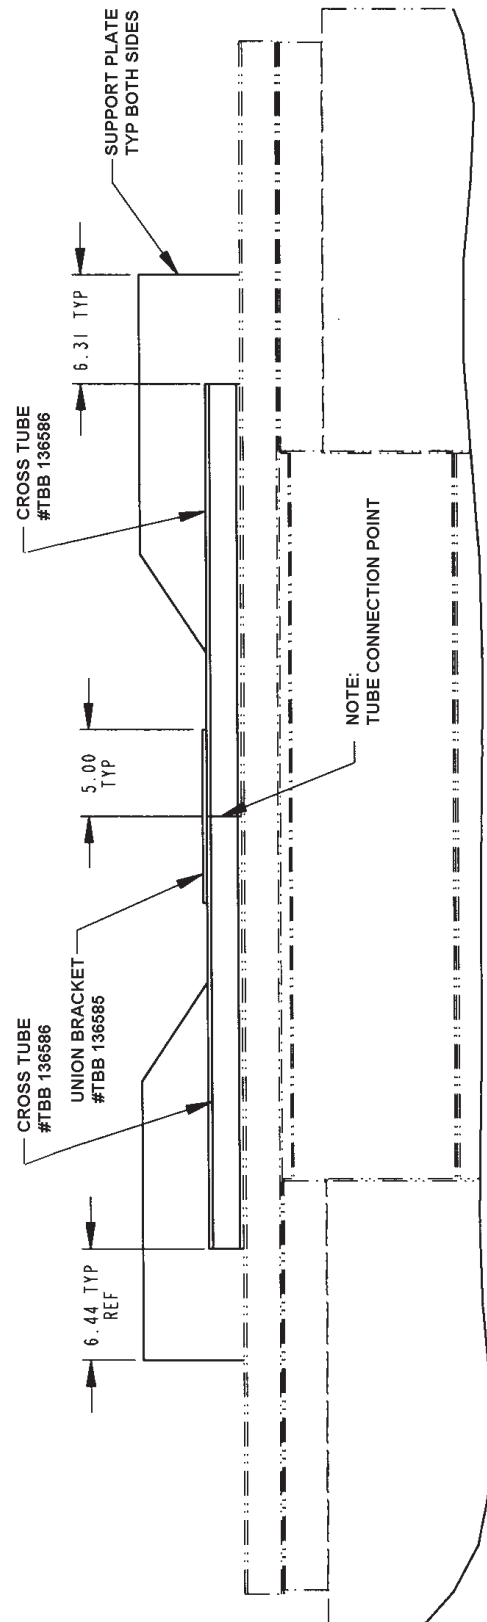
Figure 2

**VIEW FROM TOP SIDE OF FLOOR  
TO CLARIFY POSITION OF TUBES  
RELATIVE TO SUPPORT PLATES  
AND EXISTING TUBE.**

5. Prior to installation of Cross Tubes, part #TBB 136586, drill holes as indicated into support plates, as shown in **Figure 1**.
6. Insert Cross Tubes part #TBB 136586 and Union Bracket, part #TBB 136585 as indicated in **Figure 2**.
7. Weld Cross Tubes as instructed. (Note that the welds for the 1.00" dia. holes also applies for Union Bracket. **Only weld where indicated.**) See **Figures 1 and 3**.
8. Drill through new Cross Tubes, part #TBB 136586 with a "P" drill bit as required if tubes are in the way of re-installing seat bolts.
9. Re-install bolts on the seat feet, if removed in step 1.
10. Re-apply undercoating to all effected areas of the repair.
