SB-10056817-5943

| Subject: MASTER AND CHARGING SYSTEM WARNING LIGHTS ARE ON AND INSTRUMENT CLUSTER WARNING MESSAGE IS DISPLAYED (DTC P1794) | Bulletin No: 01-001/14 |
| | Last Issued: 08/05/2014 |

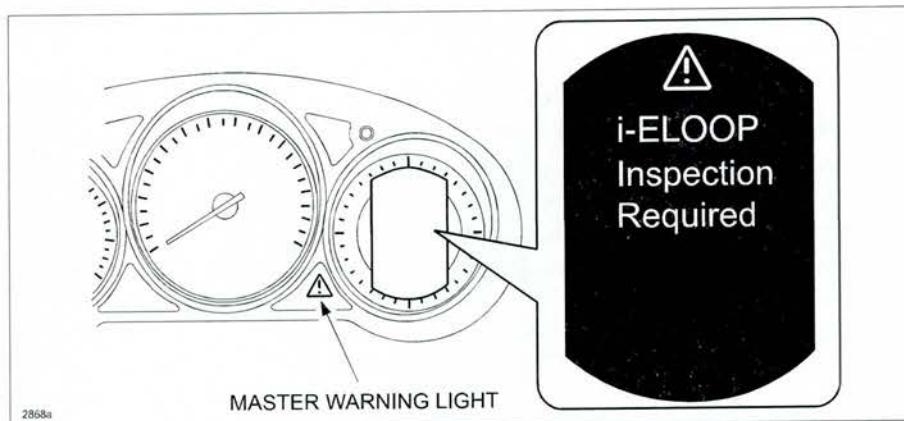
- a. Warning message "i-ELOOP Malfunction" (Mazda3) or "i-ELOOP Inspection Required" (Mazda6) is displayed in the instrument cluster information display while driving.
- b. The master warning light and charging system warning light illuminate.

- c. DTC P1794:00 (Capacitor (i-ELOOP) system: Capacitor (i-ELOOP) malfunction) is stored in PCM memory. Customers having this concern should have their vehicle repaired using the following repair procedure.

1. Verify DTC P1794:00 is stored in PCM memory.
2. Select M-MDS initial screen > "Datalogger" > "Module" > "PCM" > PID "CAP_SYS_16" and read the value.
3. Does the "CAP_SYS_16" show ON?
 - Yes - Proceed to step 4.
 - No - This service bulletin does not apply. Refer to MS3 online or Workshop Manual (section 01-02 DTC P1794:00 [SKYACTIV-G 2.5]).
4. Reboot the IDS to clear memory before reprogramming.
5. Using IDS 91.03 or later software, reprogram the PCM to the latest calibration following the "Module Reprogramming" procedure.
