Freightliner  
Service Bulletin

## SB-10056860-5190

Ride height sensor arms have broken on some vehicles equipped with Meritor WABCO Electronically Controlled Air Suspension (ECAS) due to incorrect installation of the sensor, linkage, and/or Z-bracket. In these cases, the sensor was mounted aft rather than forward of the bracket, and/or the Z-bracket was attached to the axle housing outside of the correct location, which resulted in air lines or other components impeding the full travel of the arm. When the sensor, linkage, and Z-bracket are installed in the correct position, the arm should be clear of all components during travel.

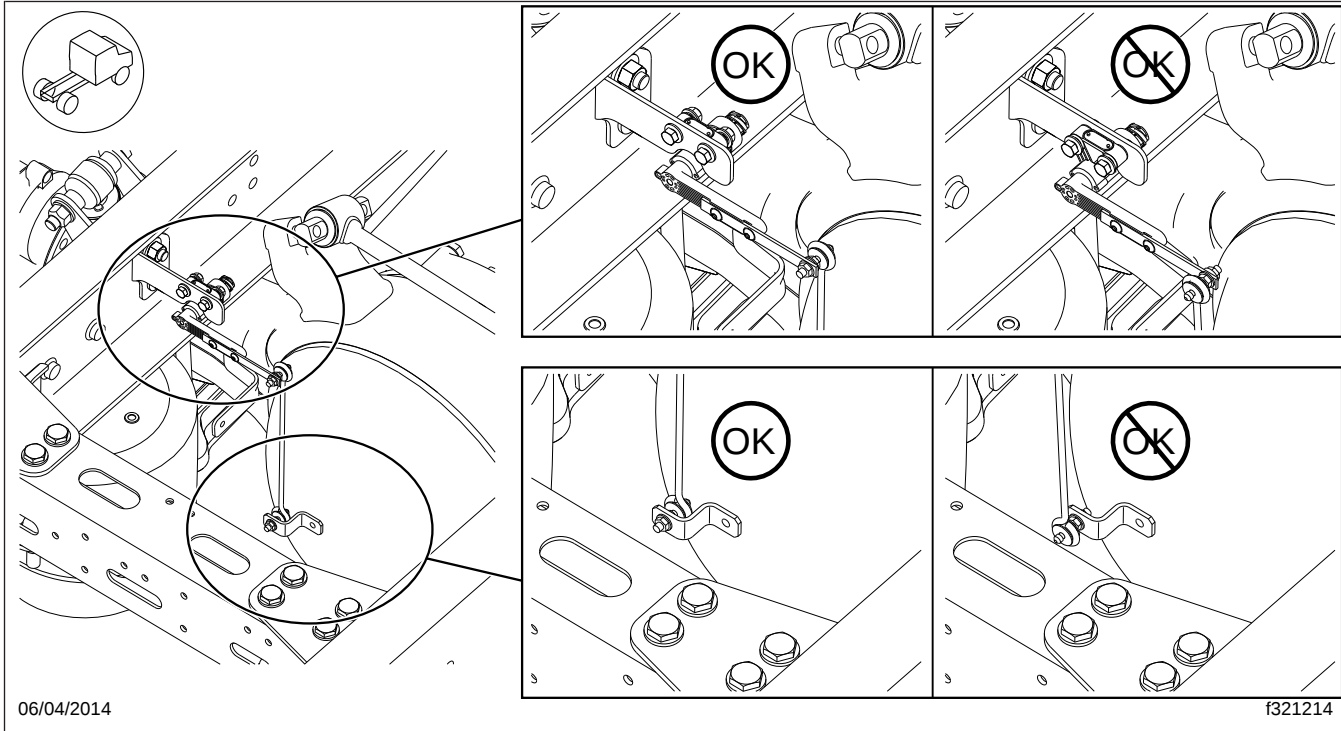
**Fig. 1, Inspection of the Ride Height Sensor Installation**

6. Compare the ride height sensor position of the vehicle to [Fig. 1](#). The sensor should be installed on the forward side of the sensor bracket, and the linkage rod should be on the forward side of the Z-bracket on the axle. The linkage rod should be upright, with no fore-aft tilt, as shown in [Fig. 2](#).

If the sensor or linkage rod are out of position, reposition them to match [Fig. 1](#). While the sensor is off the vehicle, inspect it for damage. If any cracking is found on the arm or body, replace the sensor.

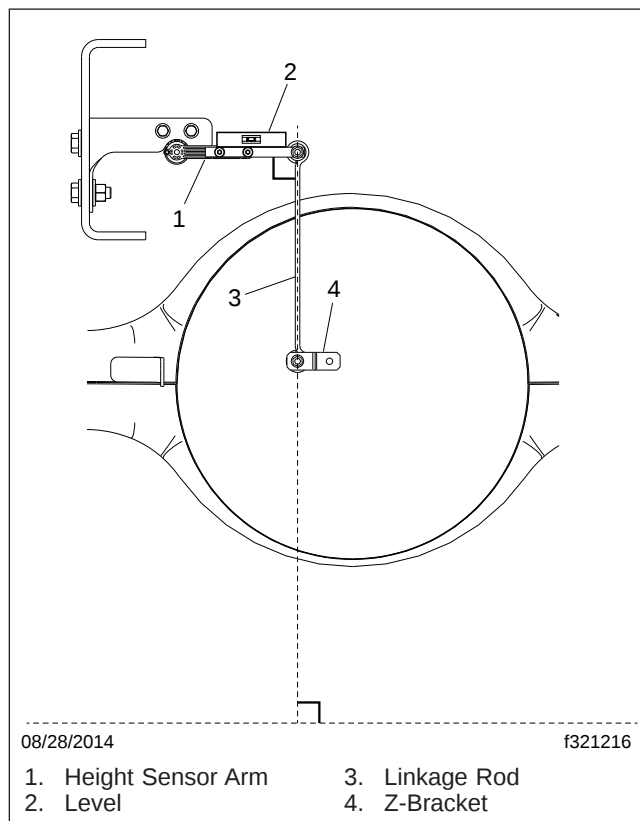
**Fig. 3, Correct Position of the Arm, Linkage, and Z-Bracket**

7. Check the position of the height sensor arm and linkage rod. See [Fig. 3](#). Check that the arm is level using a level, then use a plumb bob or carpenter's square to check that the linkage rod is at a 90° (right) angle to the level sensor arm.

If the arm is level, and the linkage rod is 90° to the arm and perpendicular to the ground, no further work is necessary.

If the arm is not level, and/or the linkage rod is not 90° to the arm, check the position of the Z-bracket as follows.

- 7.1 Remove the mounting stud from the Z-bracket.
- 7.2 Pin the arm to the sensor body using a 5/32-inch drill bit. If the arm isn't level when pinned, loosen the mounting fasteners and adjust the position of the sensor body on the frame bracket until the arm is level.

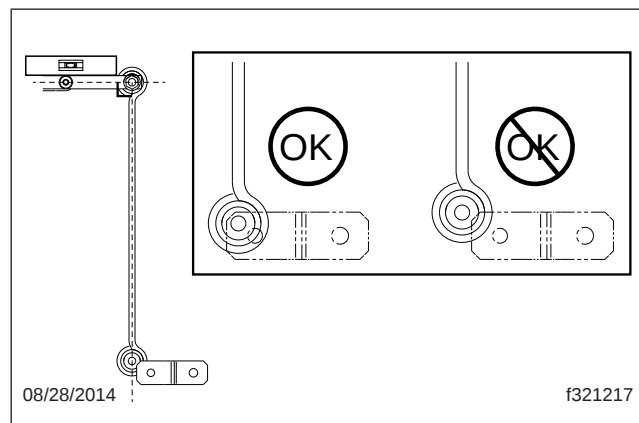
**Fig. 4, Permissible Variation in Z-Bracket Position**

- 7.3 With the height sensor arm level and the linkage rod at 90°, check if the linkage end hole is within the perimeter of the Z-bracket mounting face. See [Fig. 4](#).

If the end hole is within the perimeter of the Z-bracket mounting face, as shown in **Fig. 4**, the component positions are sufficient. No further work is necessary.

If the end hole is not within the perimeter of the Z-bracket mounting face, as shown in **Fig. 4**, install a new Z-bracket in the correct position. See **Positioning the Z-Bracket**.
