Freightliner  
Service Bulletin

## SB-10056860-5340

### General Information

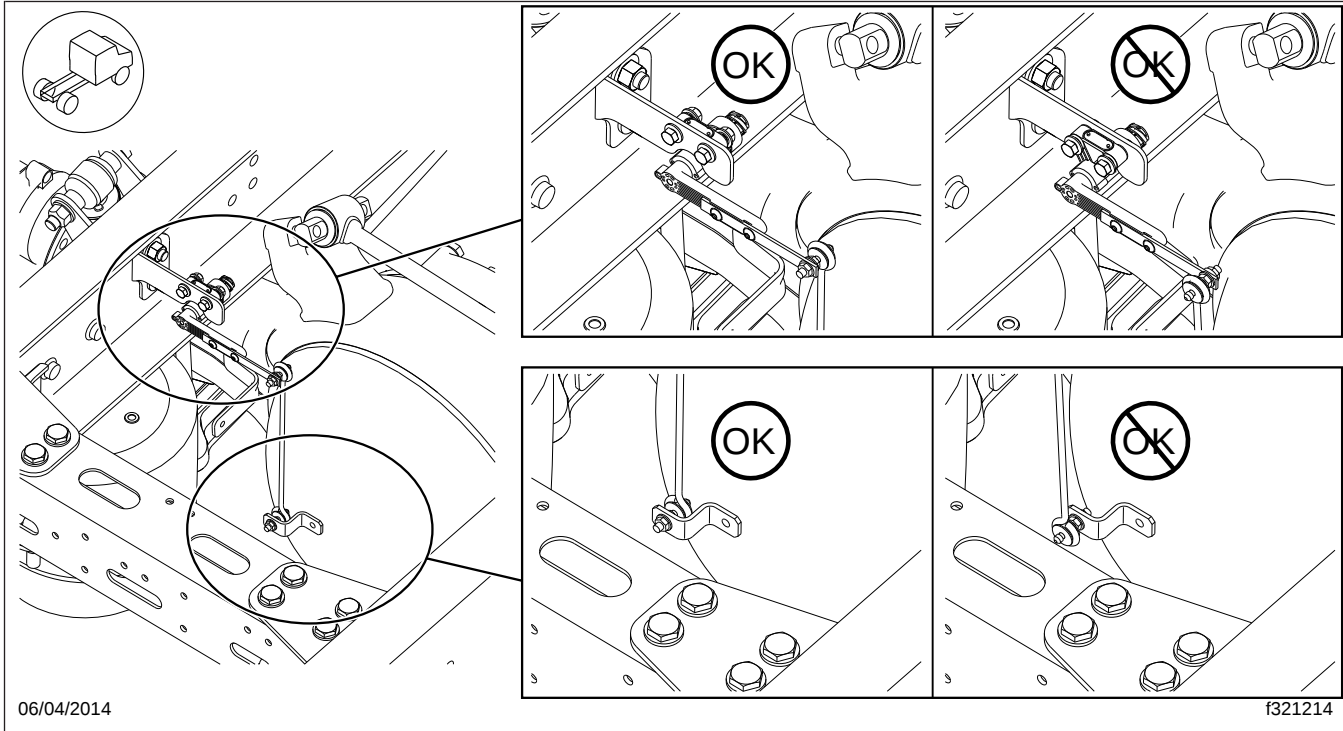
**Fig. 1, Inspection of the Ride Height Sensor Installation**

6. Compare the ride height sensor position of the vehicle to [Fig. 1](#). The sensor should be installed on the forward side of the sensor bracket, and the linkage rod should be on the forward side of the Z-bracket on the axle. The linkage rod should be upright, with no fore-aft tilt, as shown in [Fig. 2](#).

If the sensor or linkage rod are out of position, reposition them to match [Fig. 1](#). While the sensor is off the vehicle, inspect it for damage. If any cracking is found on the arm or body, replace the sensor.

10. Reconnect the linkage, making sure it matches the installation in [Fig. 1](#). Turn the key on and use the ECAS remote control to lift the suspension enough to remove the height blocks.

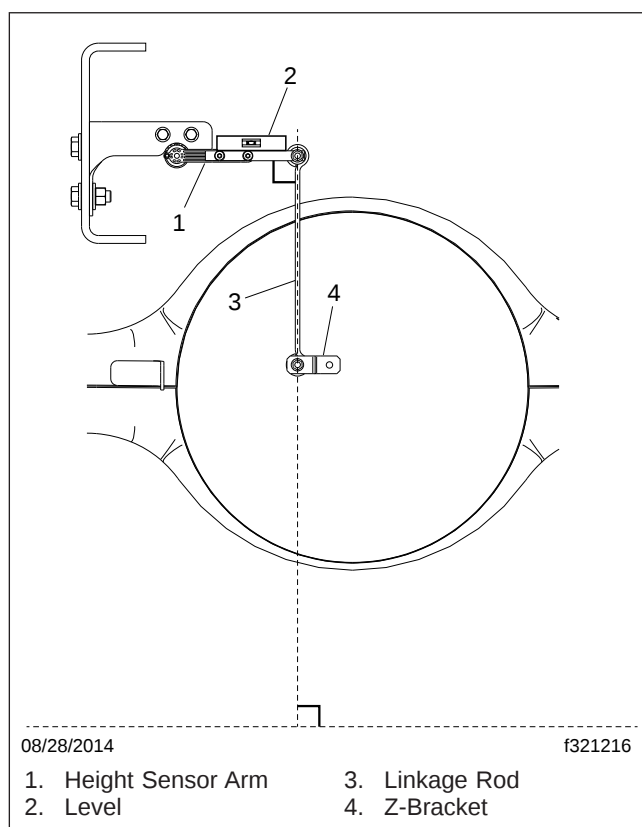
**Fig. 3, Correct Position of the Arm, Linkage, and Z-Bracket**

7. Check the position of the height sensor arm and linkage rod. See [Fig. 3](#). Check that the arm is level using a level, then use a plumb bob or carpenter's square to check that the linkage rod is at a 90° (right) angle to the level sensor arm.

If the arm is level, and the linkage rod is 90° to the arm and perpendicular to the ground, no further work is necessary.

If the arm is not level, and/or the linkage rod is not 90° to the arm, check the position of the Z-bracket as follows.

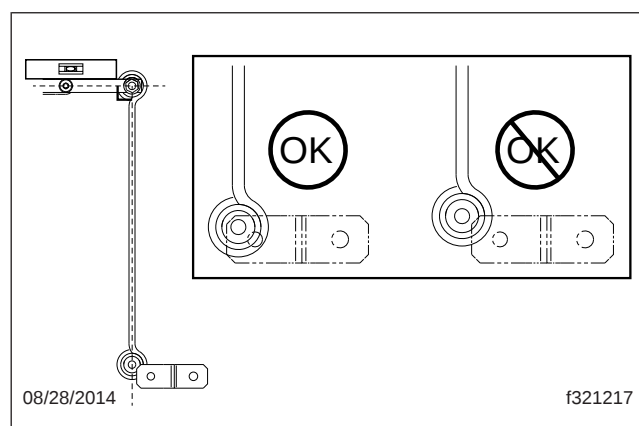
**Fig. 4, Permissible Variation in Z-Bracket Position**

- 7.2 Pin the arm to the sensor body using a 5/32-inch drill bit. If the arm isn't level when pinned, loosen the mounting fasteners and adjust the position of the sensor body on the frame bracket until the arm is level.
- 7.3 With the height sensor arm level and the linkage rod at 90°, check if the linkage end hole is within the perimeter of the Z-bracket mounting face. See [Fig. 4](#).

If the end hole is within the perimeter of the Z-bracket mounting face, as shown in [Fig. 4](#), the component positions are sufficient. No further work is necessary.

If the end hole is not within the perimeter of the Z-bracket mounting face, as shown in [Fig. 4](#), install a new Z-bracket in the correct position. See **Positioning the Z-Bracket**.

1. Cut off and discard the existing Z-bracket.
2. Grind off the welds, leaving the differential housing smooth.
3. With the height sensor arm pinned and level, and the linkage at 90° to the arm and perpendicular to the ground, hold the new Z-bracket up to the linkage rod end and axle housing and mark the new position on the housing.

4. Remove the paint where the new Z-bracket will be located.
5. With the height sensor arm pinned and level, and the linkage at 90° to the arm and perpendicular to the ground, hold the new Z-bracket up to the linkage rod end and axle housing and mark the new position on the housing.

6. Find a good spot for the welder ground clamp on the housing near the work area. Remove paint as needed for good contact.
7. Weld the new Z-bracket in place. Weld the center hole first, then the top and side edge.

8. Check the position of the height sensor arm, linkage, and Z-bracket to make sure the angles are correct with the new Z-bracket position.
9. Once the Z-bracket and housing are cool, prime and paint the new Z-bracket and anywhere paint was removed. See **Group 98** of the *Cascadia Workshop Manual*.
