Technical Service Bulletin

94 Headlight internal diagnosis before replacement, various concerns

94 14 55 2038649/1 October 15, 2014.

Model(s)	Year	VIN Range	Vehicle-Specific Equipment
Q7	2010 - 2016	All	Not Applicable

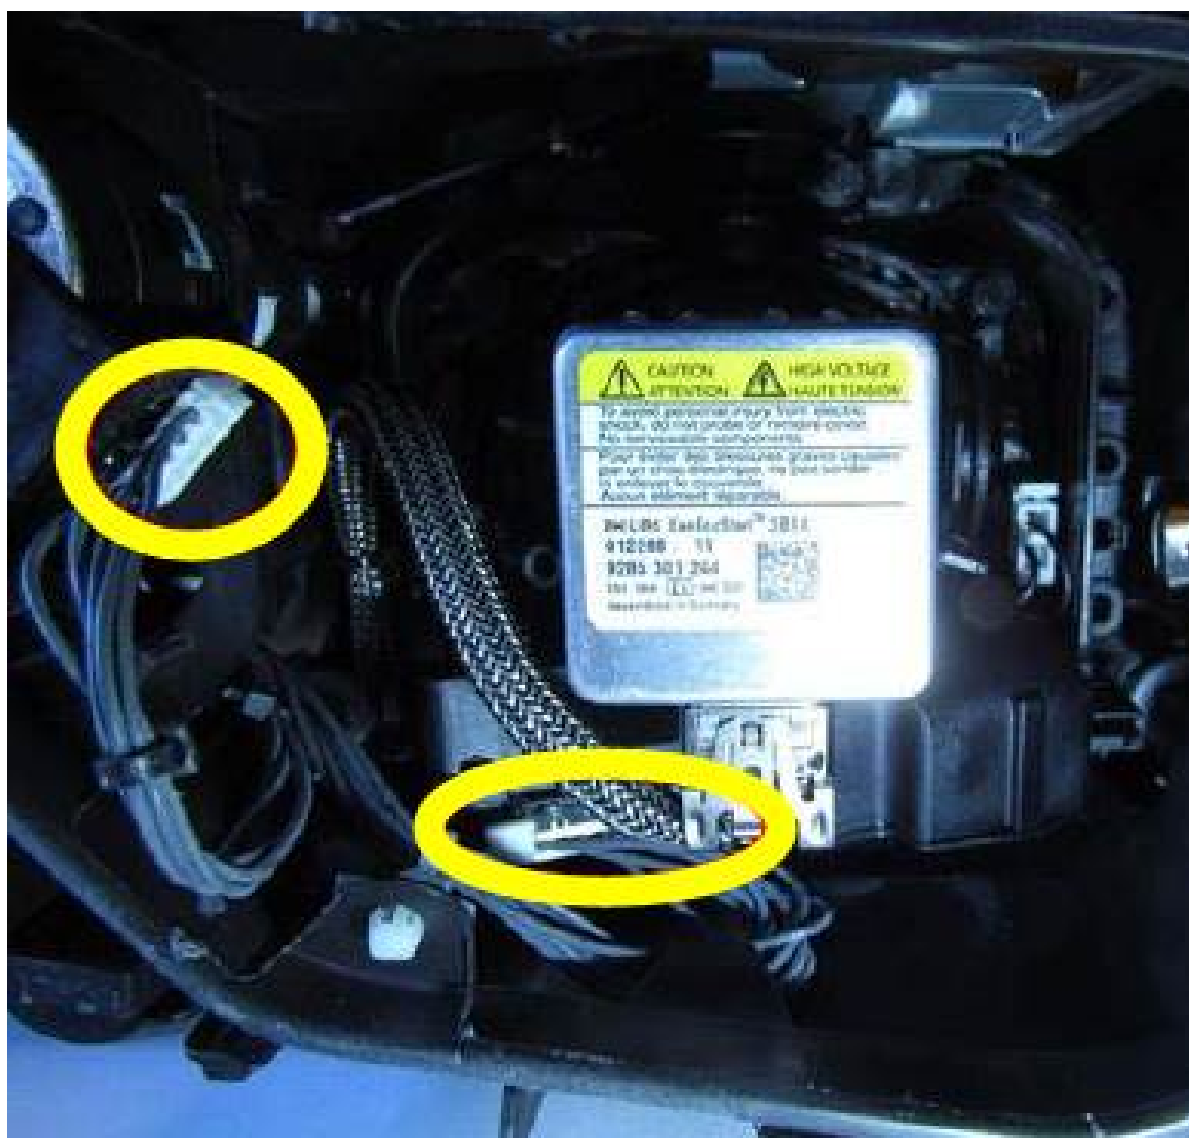
For symptom A (Headlight range control inoperative):

Figure 1. Check these connectors.

3. If any connectors are not correctly plugged in, check connector for damage. If no damage is found, reconnect the connector. Do not use a screwdriver or other metal object. If all connectors were plugged in correctly, this bulletin does not apply.
4. Reconnect the headlight to the vehicle, then check the headlight operation. It is not necessary to fully install the headlight to test the headlight operation.
5. If headlight operation is fully restored, fit and adjust the headlight.

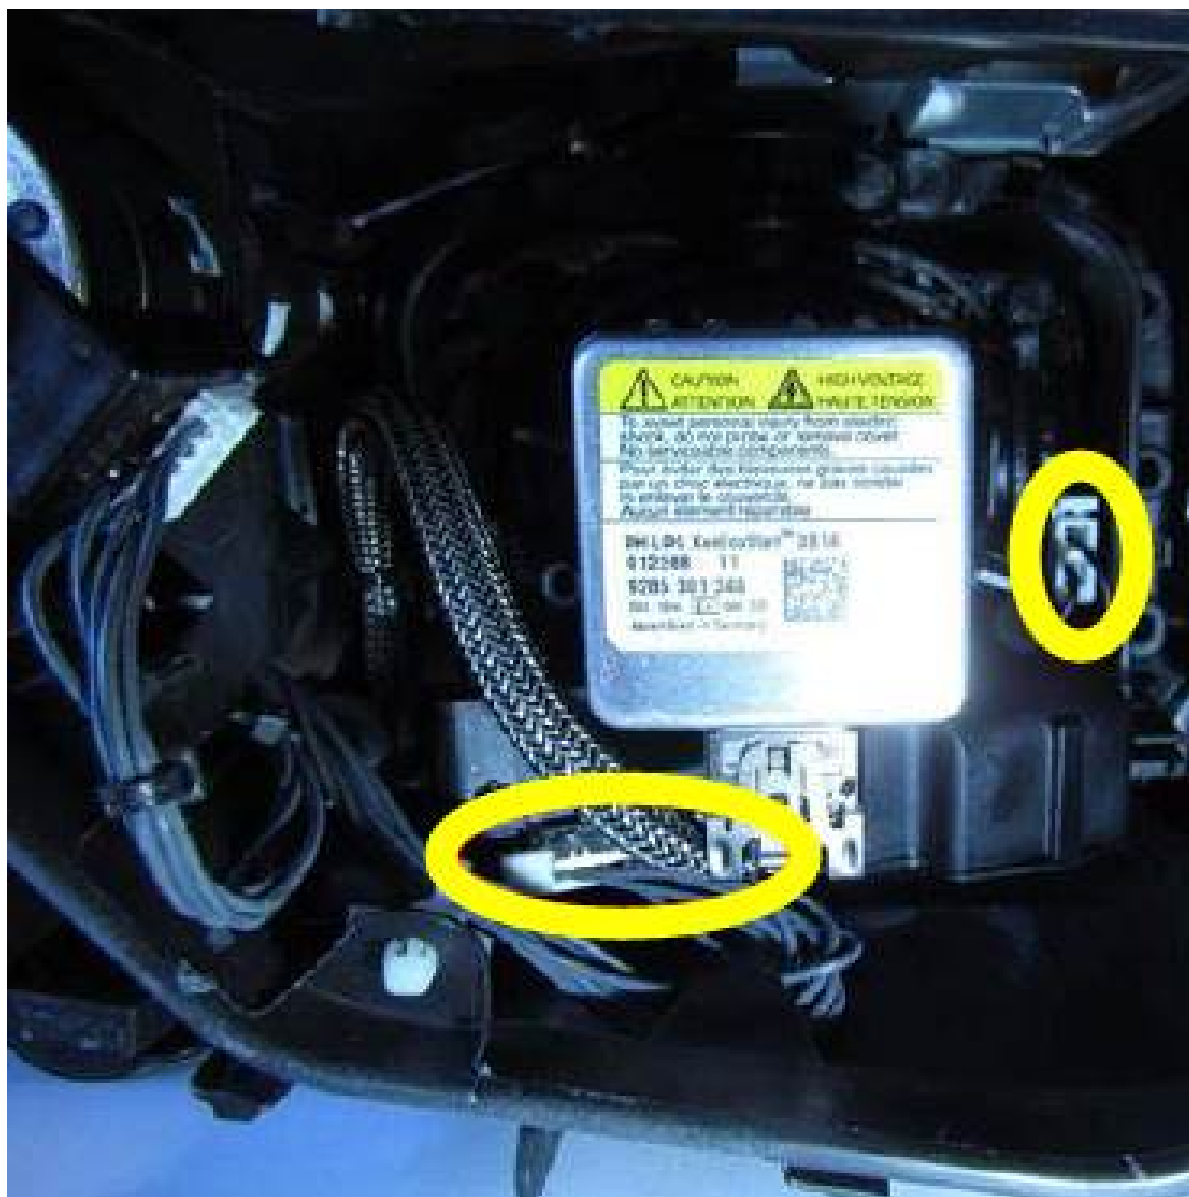
For symptom B (Xenon high beam inoperative):

Figure 2. Check these connectors.

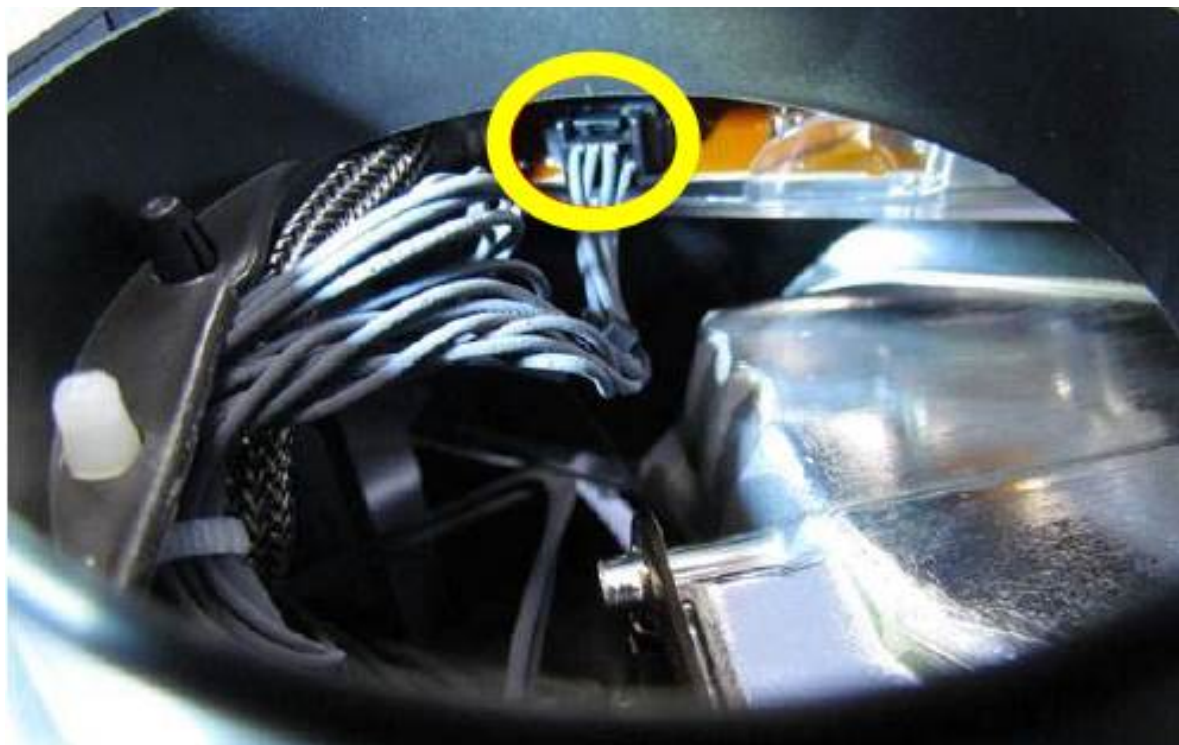
For symptom C (Daytime running light inoperative):

Figure 3. Check these connectors.

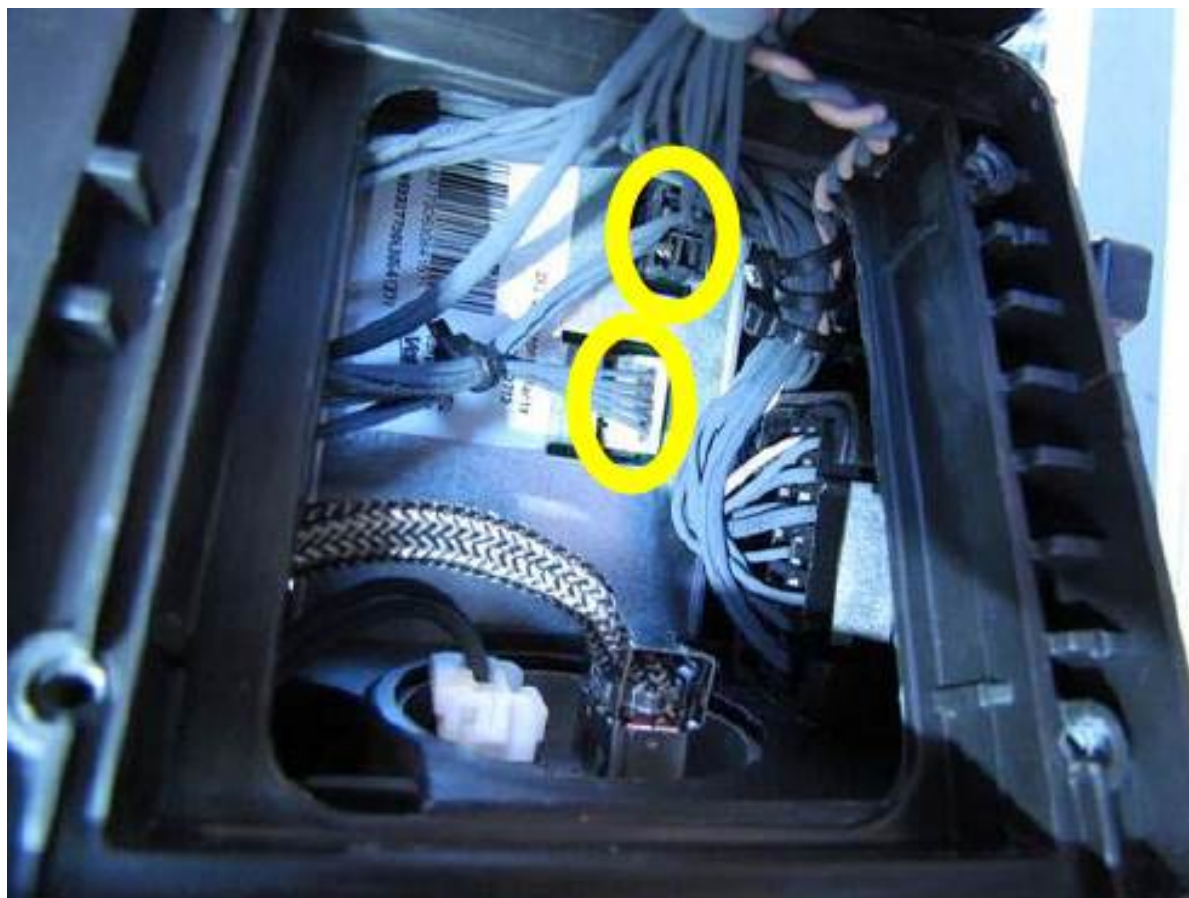
Figure 4. Check these connectors.
