Technical Service Bulletin

94 Headlight internal diagnosis before replacement, various concerns

94 14 53 2038601/1 October 7, 2014.

SB-10056903-9416

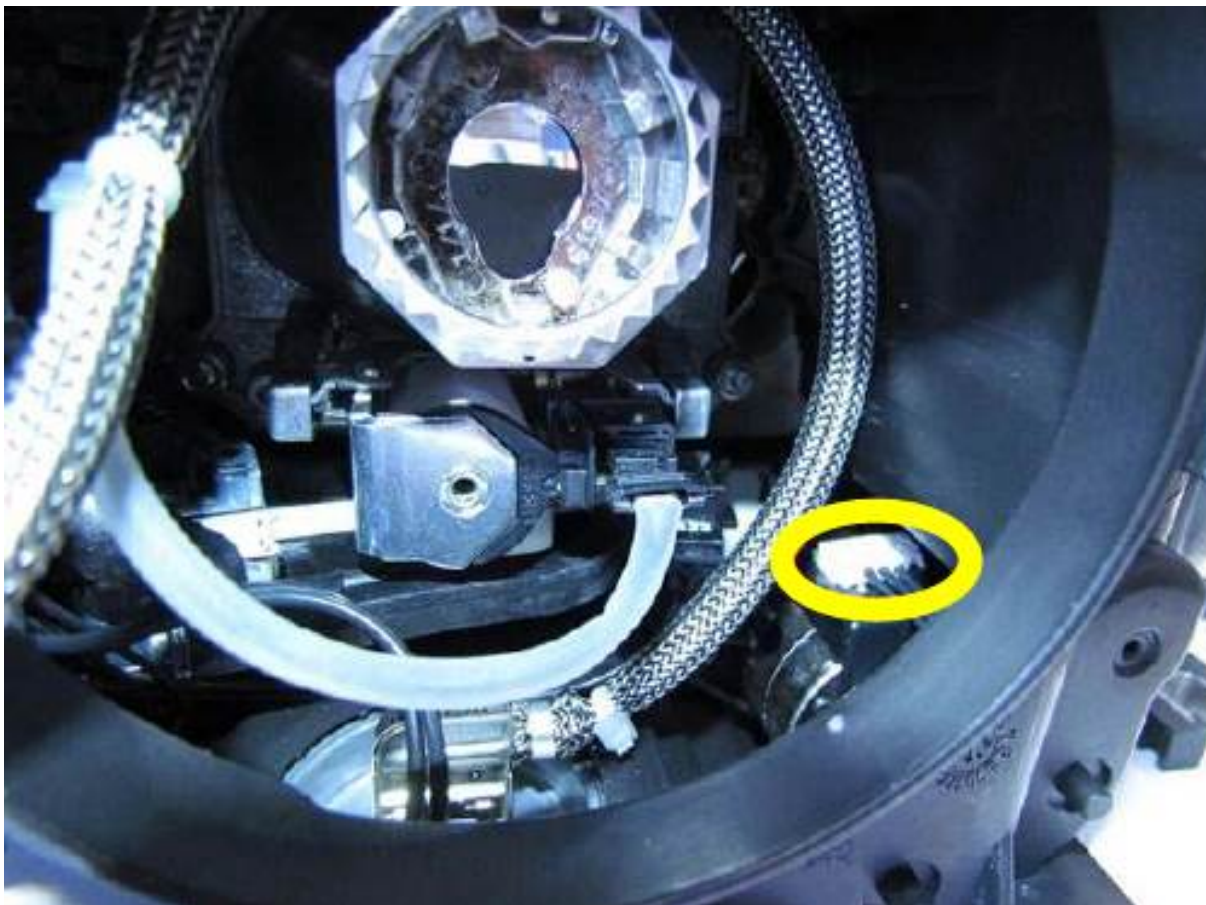
For symptom A (headlight range control inoperative):

Figure 1. Check this connector on vehicles with PR codes 8Q3 or 8Q5.

3. If any connectors are not correctly plugged in, check connector for damage. If no damage is found, reconnect the connector. Do not use a screwdriver or other metal object. If all connectors were plugged in correctly, this bulletin does not apply.
4. Reconnect the headlight to the vehicle, then check the headlight operation. It is not necessary to fully install the headlight to test the headlight operation.
5. If headlight operation is fully restored, fit and adjust the headlight. Additional adaptations (radar sensor, overhead camera, night vision) may be necessary, depending on vehicle equipment.

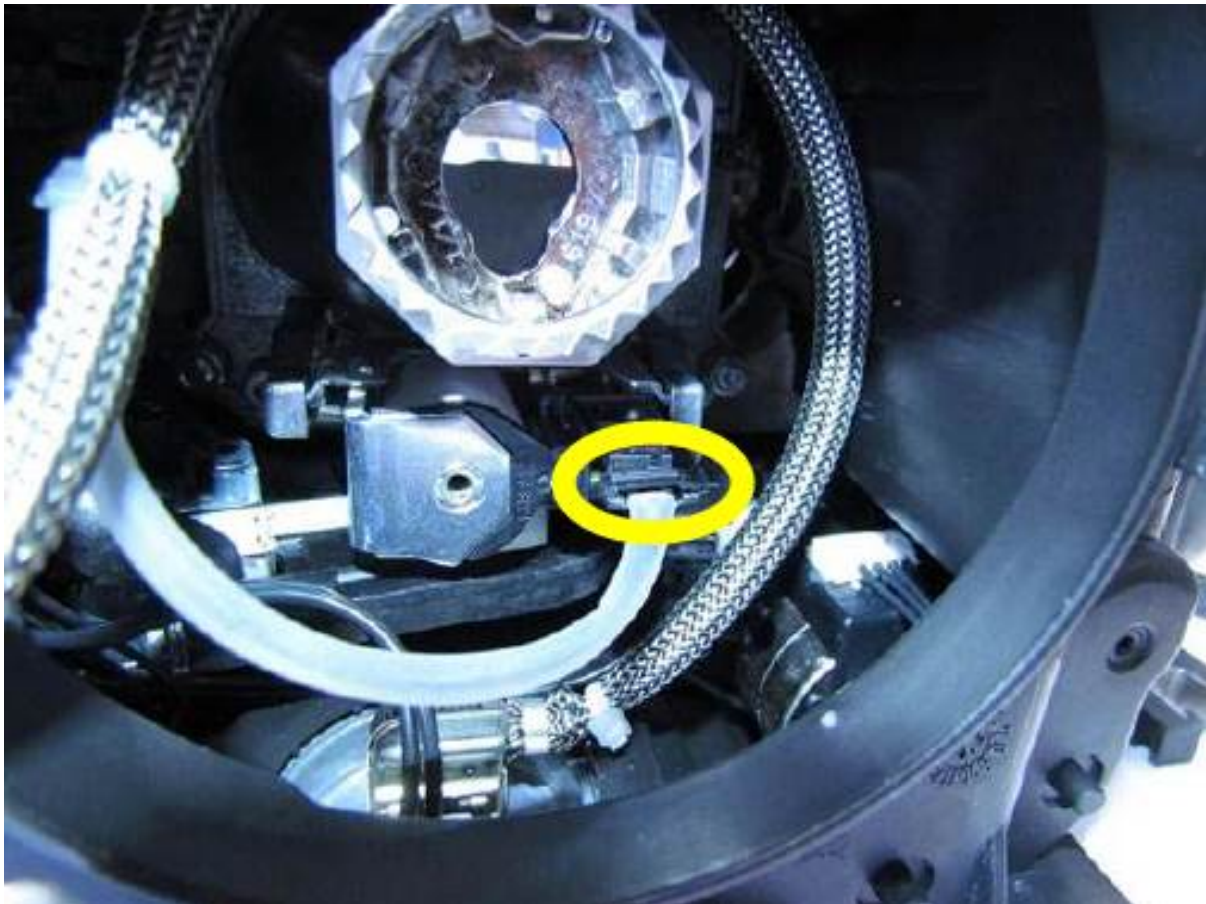
For symptom B (Xenon high beam shutter inoperative on one side (low beam functioning)):

Figure 2. Check this connector on vehicles with PR code 8Q3 or 8Q5.
