October 1, 2014

45D7 UPDATE - TPMS/ESC Software (NVLW)

SB-10056908-4645

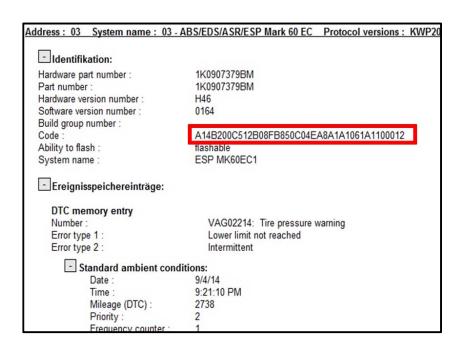
Connect battery charger and scan tool to vehicle and navigate to Guided Fault Finding. After control module interrogation is complete, record ABS coding information as shown below <rectangle>.

- 2. Select Diagnosis=>Special Functions=>Adapting Software=>Perform Test.
- 3. Update the ABS Control Module using the SVM Unit code as listed in the table below:
- 4. If necessary, refer to instructions in TB, 2014603: 00 Software Version Management (SVM), operating instructions.

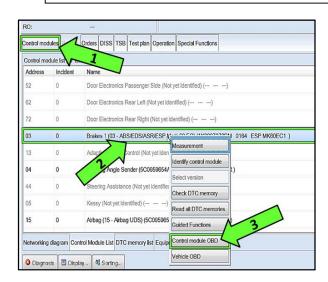
Tip: If on-line coding is not successful, carry out manual coding of the ABS as shown below.

Manual ABS coding steps:

- ← From the Control modules tab <arrow 1>. right click on 03 for ABS <arrow 2>.
- Select Control module OBD <arrow 3>.
