SERVICE BULLETIN

Classification: EC14-005	Reference: NTB14-103	Date: November 4, 2014
------------------------------------	--------------------------------	----------------------------------

2013-2014 FRONTIER; FUEL TANK HARD TO FILL

APPLIED VEHICLE: 2013 – 2014 Frontier (D40)
Shortbed Crew Cab vehicles **only**

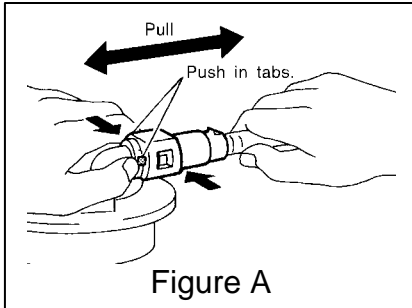
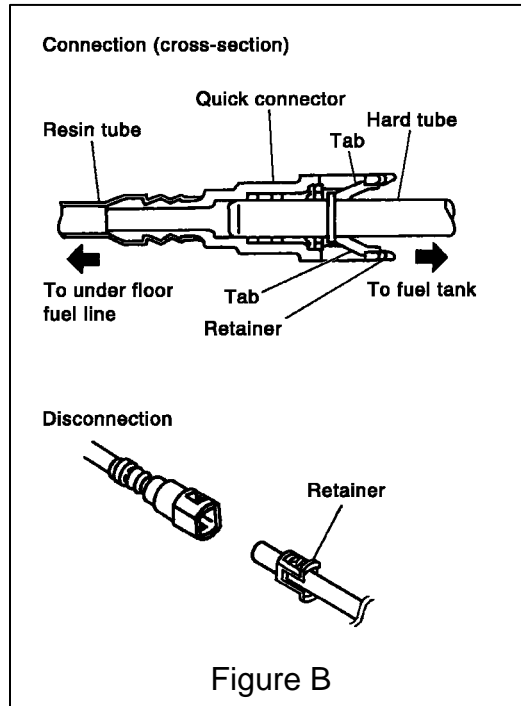
NOTE: See Figure A and Figure B for detail of "Quick connector" retainer release.

The fuel tank is slow or difficult to fill.

1. Disconnect vent hose at canister.
