SERVICE CAMPAIGN BULLETIN

SUBJECT:			No:	SC-14-003	
				DATE: <b>October, 2014</b>	
				L: 2012 i–MiEV	
CIRCULATE TO:	[X] GENERAL MANAGER	[X] PARTS MANAGER		[X] TECHNICIAN	
[X] SERVICE ADVISOR	[X] SERVICE MANAGER	[X] WARRANTY PROCESS	OR	[X] SALES MANAGER

The undercarriage on certain 2012 i–MiEV vehicles, along with the bolts securing the Main Drive Lithium–ion battery under covers and non–essential ground connections, may be susceptible to rust.

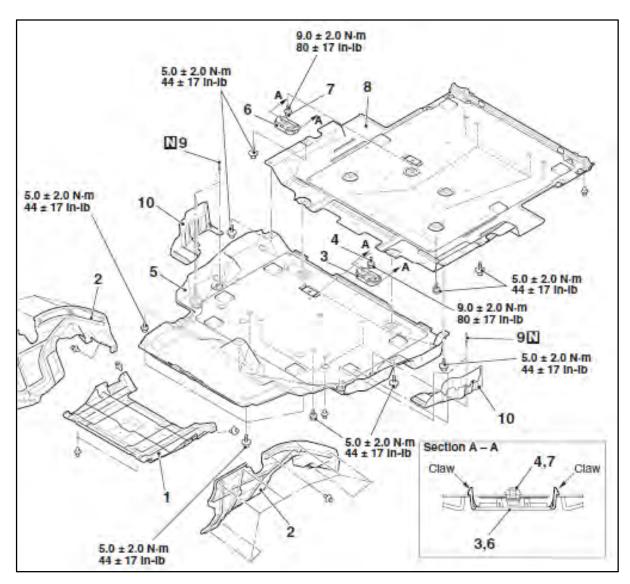
4. If the non-essential ground bolts are rusted or damaged, skip Step 5 and go to Step 6.

- 1. Place the vehicle on a lift, shift the selector to PARK, set the parking brake, and turn the electric motor switch to the OFF position. Raise the vehicle.
- 2. Remove the front and rear plug covers (#3 and #6 refer to the diagram below) and the non–essential ground bolts (#4 and #7 refer to the diagram below).
- 3. Remove the front under cover (#5 refer to the diagram below), then remove the rear under cover (#8 refer to the diagram below.
