Service Bulletin

Bulletin No.: 14-06-04-002A

Subject: Information for No Start Due to Inoperative LPG Fuel Pump Resulting from Upfitter Modifications

Models: 2012-2015 Chevrolet Express
2012-2015 GMC Savana
Equipped with Liquefied Petroleum Gas (LPG) – RPO KO7

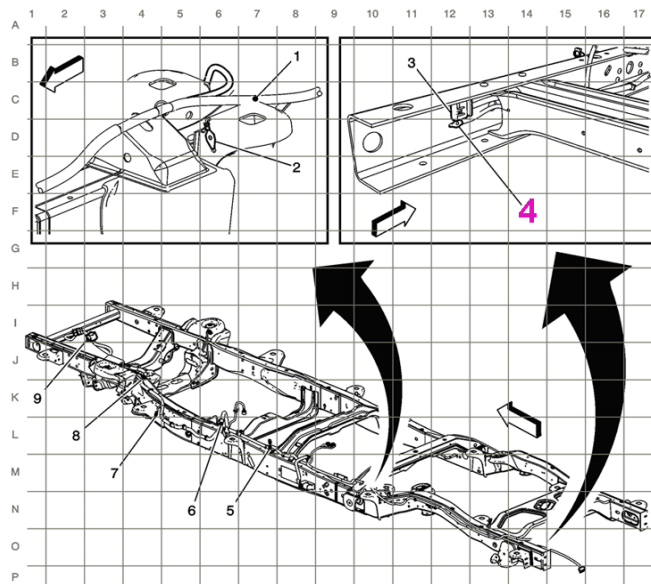
3679777

1. Review the original OEM location of G400 (4) in the graphic. The new G400 location selected by the upfitter will be in this general area of the chassis frame.

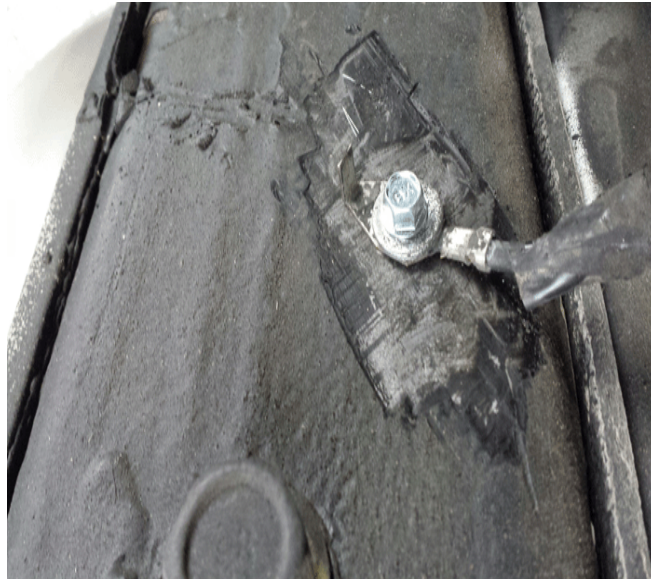
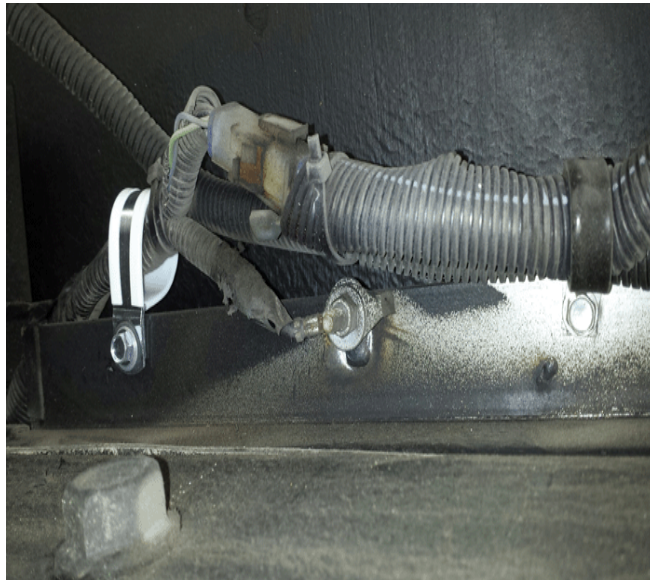
2. Review the graphics of the several new G400 locations that were possibly selected for use by the upfitter on the chassis frame in order to become familiar with the various locations.

3. Using GM approved residue-free solvent or equivalent, remove any grease from the G400 terminal.
4. Disconnect and remove the G400 terminal from the chassis frame.

5. Carefully remove any corrosion from both sides of the G400 terminal.
6. Using GM approved residue-free solvent or equivalent, remove any grease from the area and allow to dry.

7. Carefully remove any factory coating from the area until clean bare metal is visible.
8. Prep the repair area, as outlined in the Recommendations/Instructions in the latest version of PI0564: Wax Coating on Frame Peeling, Metal Shows Corrosion/Rusting.

9. Select a conductive fastener for the repair. Refer to the latest version of Bulletin 10-08-45-001: Information for Electrical Ground Repair - Use New Replacement Fasteners with Conductive Finish.

10. Using a small brush, apply Dielectric Lubricant to both sides of the G400 terminal, install and secure as needed.
11. Perform the corrosion control procedure as outlined in the Recommendations/Instructions in the latest version of PI0564.

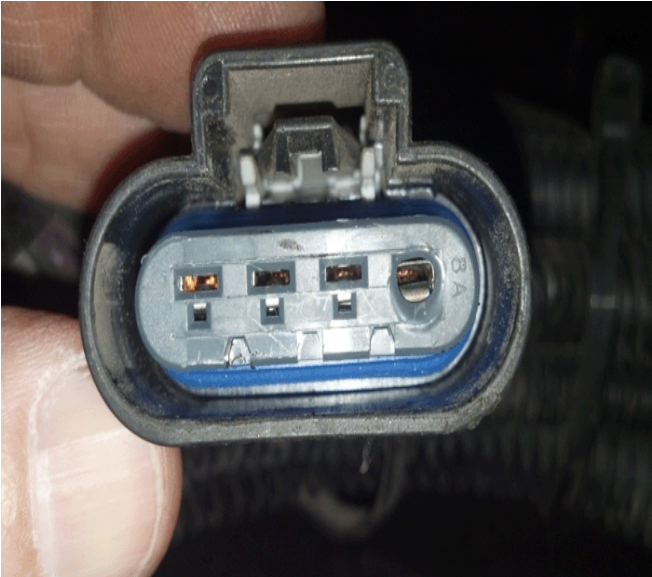
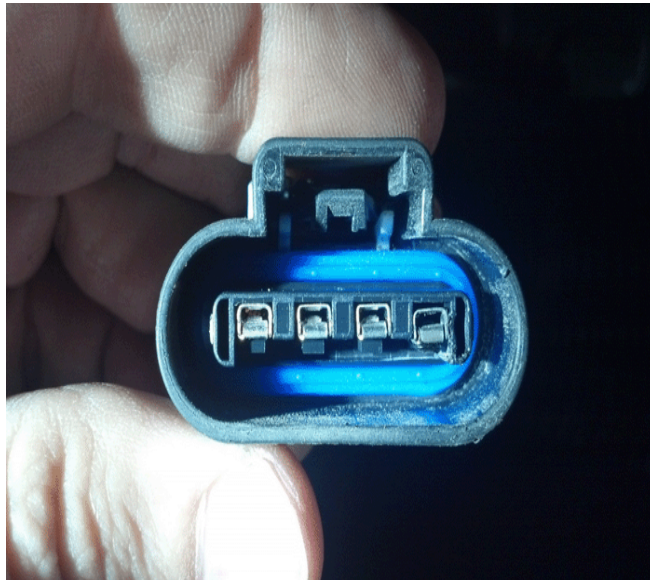
2. The X305 connector is shown with the plastic insert in position and then removed. Inspect the X305 connector for intermittent conditions and poor connections. Refer to Testing for Intermittent Conditions and Poor Connections in SI.
 - ⇒ If intermittent conditions and poor connections are found, repair as needed. Refer to Repairing Connector Terminals, Connector Repairs and Wiring Repairs in SI.
