SB-10056995-7378 Service Bulletin

Bulletin No.: P11307

Subject: Malfunction Indicator Lamp (MIL) Illumination with DTC P0171: Fuel Trim System Lean

Models: 2012-2014 Chevrolet Sonic
Condition/Concern

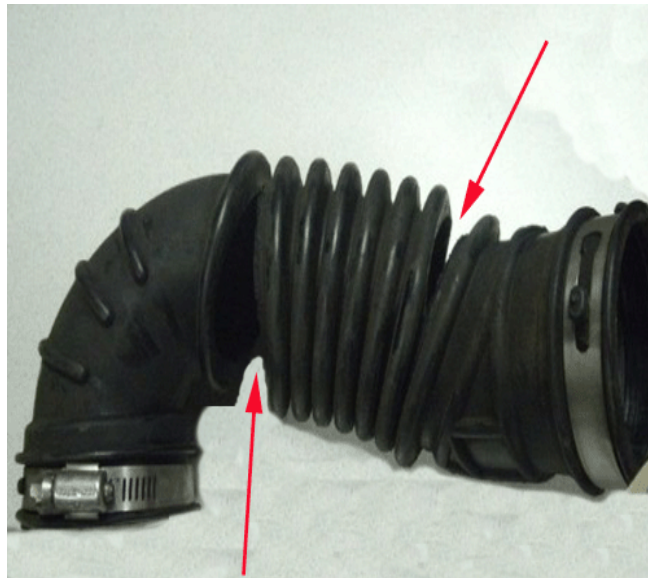
3976038

This may be due to the air cleaner outlet duct, located after the mass air flow (MAF) sensor, having splits allowing improper airflow into the induction system.

In the example above are splits that can be present.

1. Inspect for splits as shown in the example above. If splits are detected, proceed to the following step.
2. Loosen the clamp (1) that secures the duct (2) to air cleaner assembly.
3. Loosen the clamp (1) that secures the duct (2) to the throttle body assembly or turbocharger.
4. Replace the outlet duct with the service part listed below.
5. Secure the clamps on the new duct.
6. Clear DTCs and reset fuel trim if applicable.

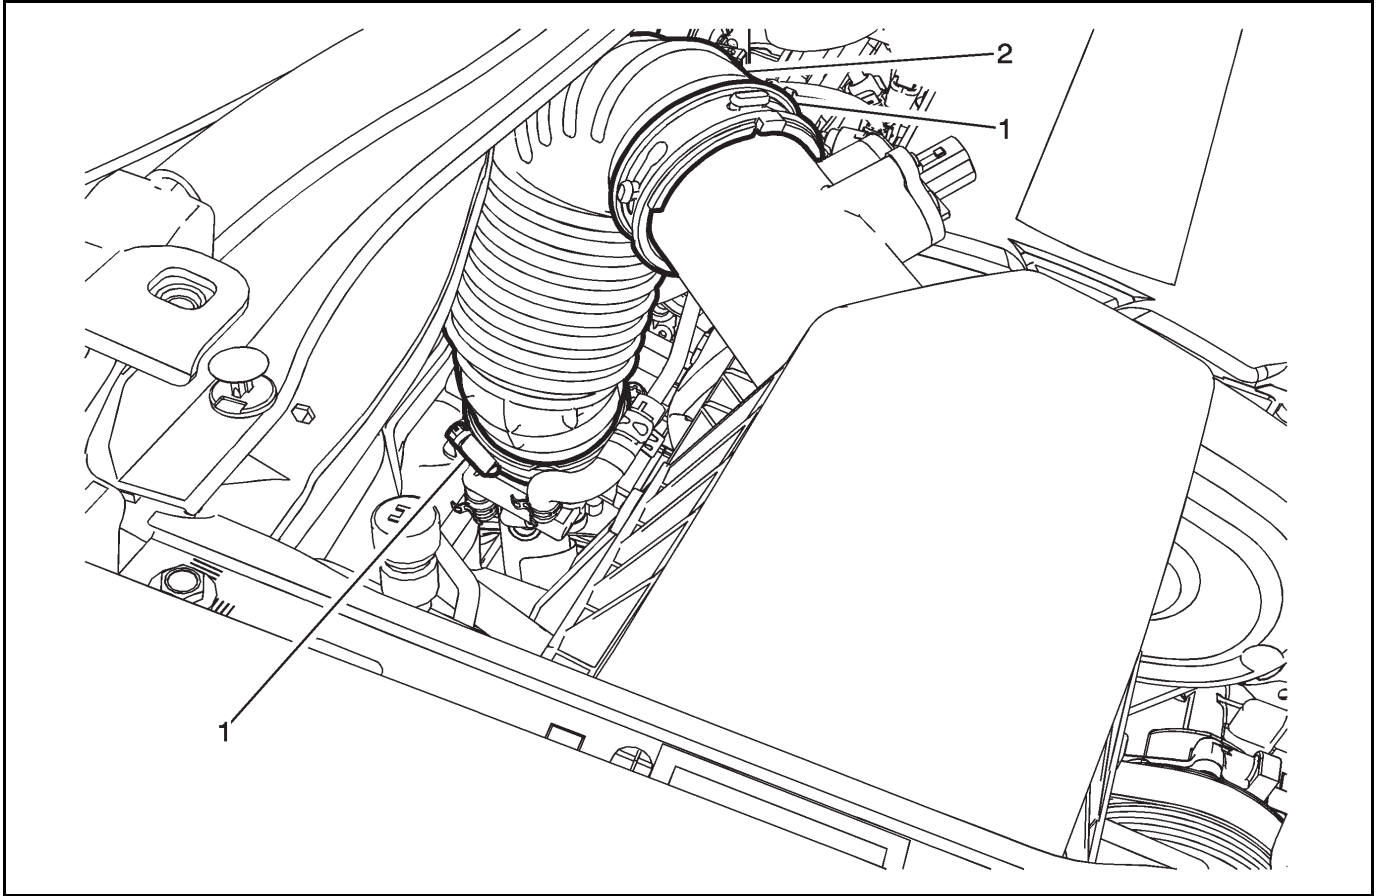
2505699

Note: The illustration above is a non turbocharger engine.
