GROUP Electrical	MODEL 2014MY Sorento (XMa) w/IMS Seats
	NUMBER ELE 069	DATE September 2014
TECHNICAL SERVICE BULLETIN		
SUBJECT: DRIVER'S SIDE POWER WINDOW SWITCH REPLACEMENT

SUBJECT: DRIVER'S SIDE POWER WINDOW SWITCH REPLACEMENT

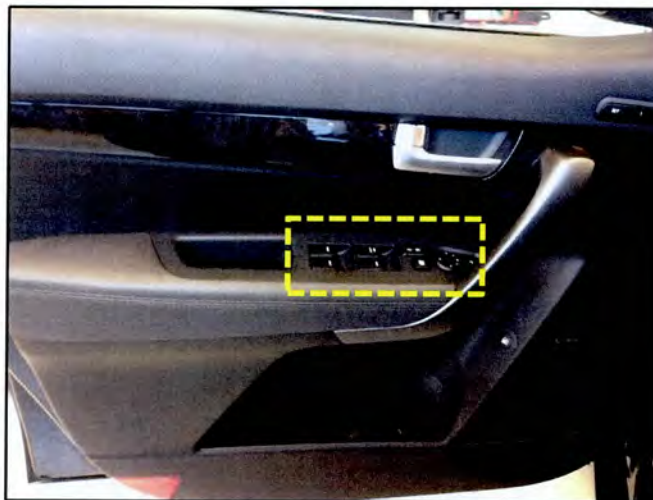
Master Power Window Switch

This bulletin provides the procedure to replace the window motor switch of some 2014MY Sorento (XMa) vehicles, produced from December 17, 2012 through December 13, 2013, which may exhibit an intermittent parasitic draw concern. Before conducting this repair, verify that TSB ELE057/SA163 - IPM Logic Improvement - has been performed on the vehicle. **This procedure applies ONLY to vehicles equipped with Integrated Memory System (IMS) Seats.**
