Bulletin No.: PI1325

**Subject:** Instrument Cluster Goes Blank, Lights Turn On and Off, Gauge Pointers Drop, Bluetooth Pairing Issues

**Models:** 2014 Chevrolet Silverado 1500  
2014 GMC Sierra 1500

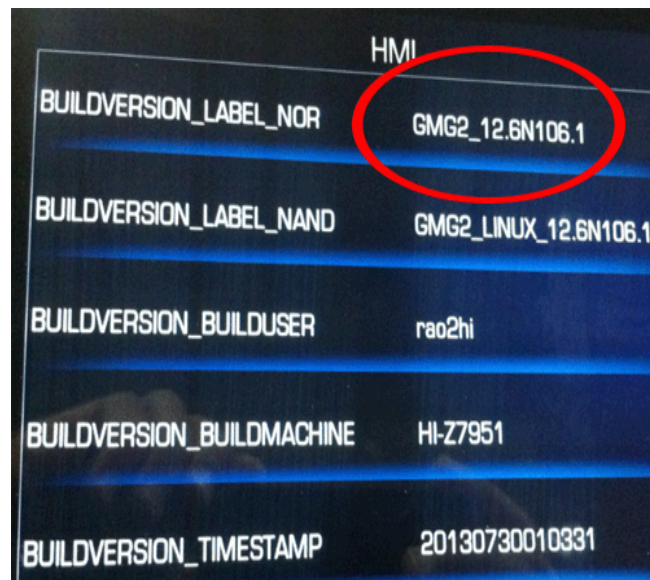
3749596

Before updating software, check the HMI (Human Machine Interface) build version. The HMI build version label should be GMG2.12.6N106.1 or earlier.

**Caution:** If the software version is later than GMG2.12.6N106.1, damage to the HMI module may occur. DO NOT PROCEED WITH THIS PI.

To verify the HMI build version, on the radio push the following button combination together (see below), then select HMI from the onboard development screen.
