Service Campaign Bulletin

Campaign No 2014050007, July 2014

SUBJECT: **Model 117 AMG with Engine 133, Model Year 2014**
Check Turbocharger, Replace if Necessary

This Service Campaign has been initiated because Daimler AG (DAG), the manufacturer of Mercedes-Benz vehicles, has determined that due to contamination in the turbo charger oil feed lines the turbo charger may need to be replaced. An authorized dealer will check, and if necessary, replace the turbo charger and oil lines at the next workshop visit.

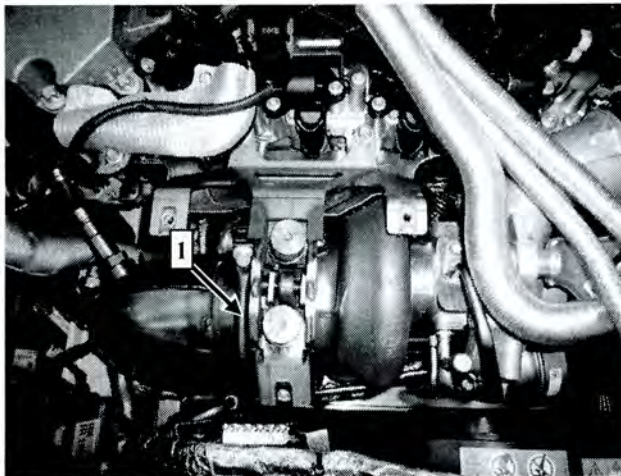
Figure 1

3. Loosen profile clamp (1, Figure 1) and move exhaust pipe to one side.

i **Installation Note:**

- Replace profile clamps and bolts
- Torque profile clamp bolt to: 20 **Nm**.

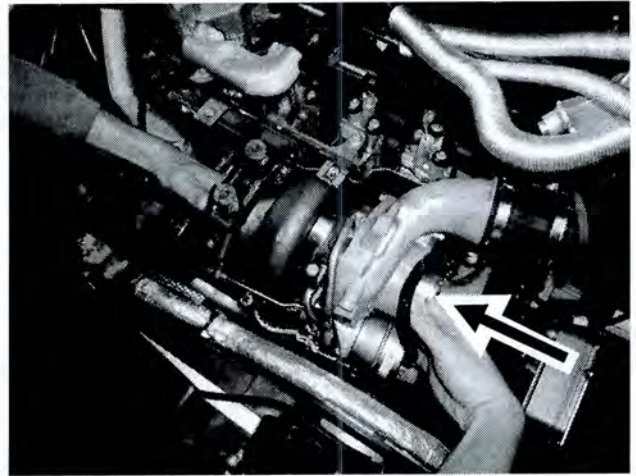
Figure 2

Detach air intake pipe refer to WIS: AR09.10-P-8131MTA.
- i** **Note:**
Place to one side with connected lines.
5. Push turbocharger shaft back and forth repeatedly by hand to relieve any residual oil pressure (Figure 2).
- i** **Note:**
Do not use any tools.
6. Slide shaft up to end stop in direction of turbine by exerting pressure by hand on compressor impeller shaft in direction of arrow (Figure 2).

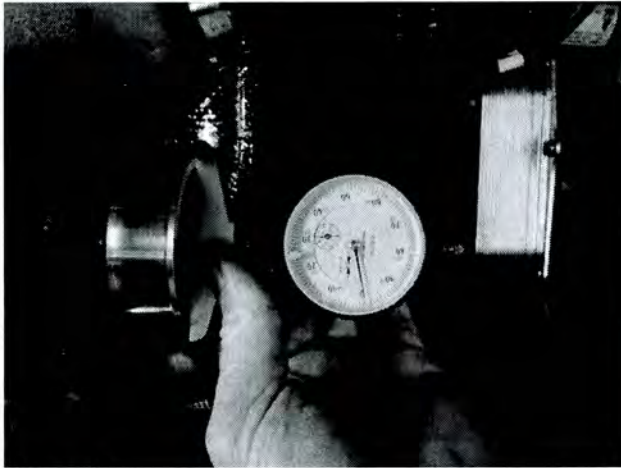
Figure 3

7. Position depth gage with measuring bridge at compressor housing in the middle so that it is level (Figure 3).

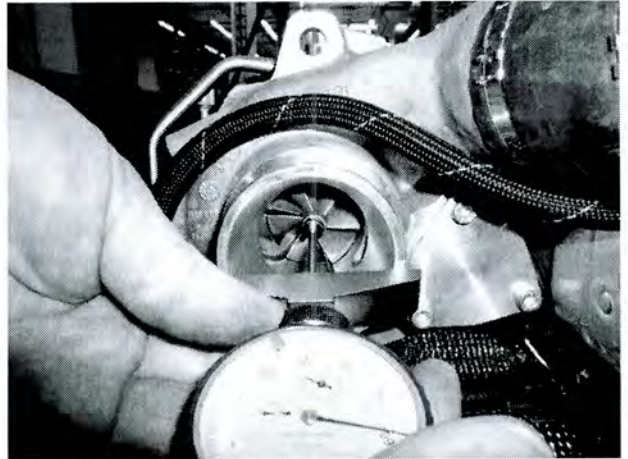
Figure 4

Set depth gage to "ZERO". The measuring tip must make level contact with shaft (Figure 4).

9. **g** Read off axial play.
 - If axial play is *greater than or equal to* 0.08 mm (NOT OK): Proceed to Subject B.
 - If axial play is *less than* 0.08 mm (OK): End measure.
10. Assemble in reverse order.

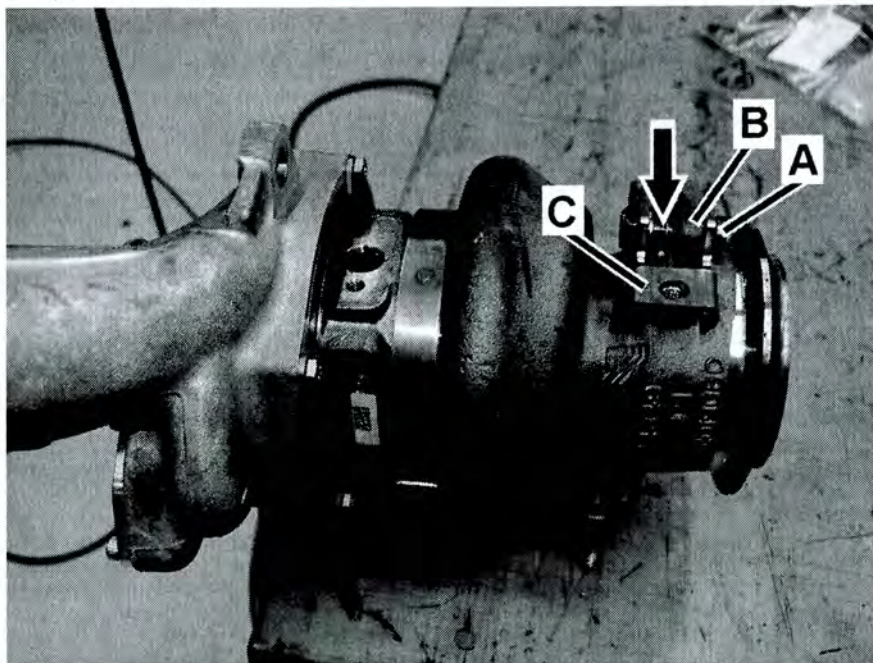
Figure 5

- Engine must be cold.
- Do not drain coolant from cooling system.
- Do not remove: Coolant lines from coolant hose, coolant line from engine block, exhaust pipes from mounting brackets on body, O² sensors from exhaust system, cable tie at purge lines.
- Do not separate ventilation lines from mounting bracket (step 5 in WIS instructions: AR09.40-P-6020MTA). Place ventilation lines along with air intake duct to one side as an assembly.
- In the event turbo mounting bracket bolt (A, Figure 5) is binding in turbo mounting eyelet (B), cut through bolt (at arrow) with rotary cutting tool (etc.) to remove bolt (A) from turbo.

- Transfer mounting bracket (C) to new turbo and install new bolt (A, refer to parts table for part number).
