**SB-10057064-3254**

Bulletin No.: PI1357

# Service Bulletin

**Subject:** Air Bag Light On, Service Air Bag Message Displayed on DIC

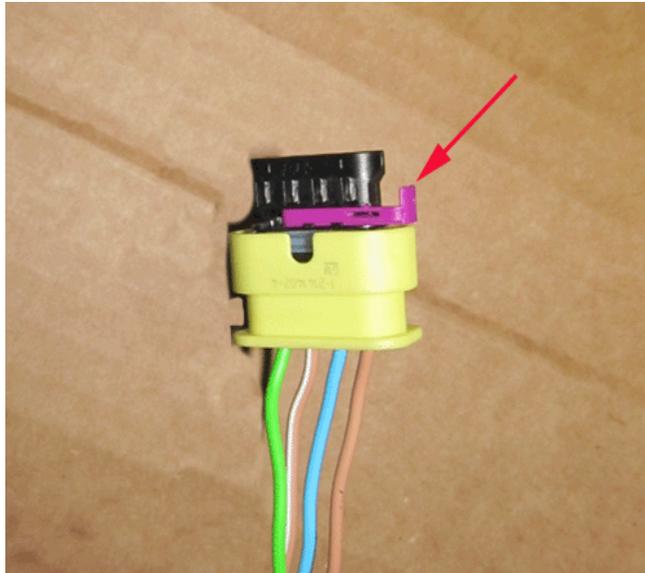
3990716

**Note:** A yellow 4-way connector (passenger) as shown above is similar to the 6-way yellow connector (driver).

5. Remove the terminal position assurance (TPA) lock as shown above.

**Note:** Always use care when removing a terminal position assurance (TPA) in order to avoid damaging it.

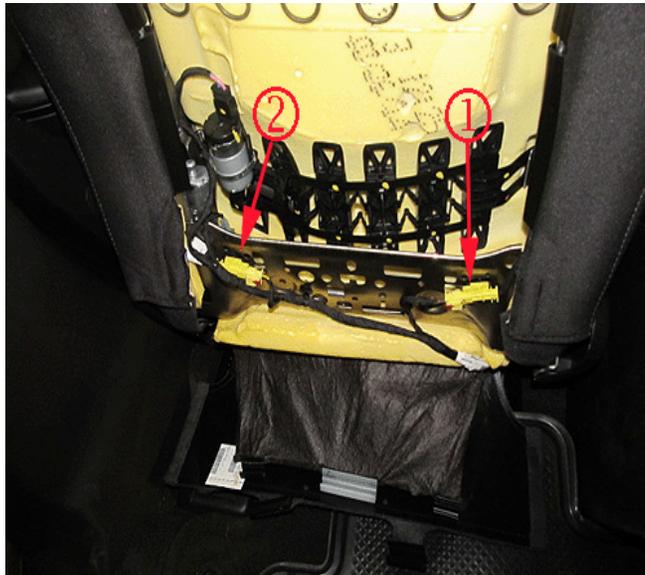
4009158

**Note:** The illustration above is of the driver's seat. The passenger seat will only have the seat airbag outboard connector (2) on the right side of the seat.

14. Disconnect the front seat back airbag inboard (1) and/or outboard (2) connector(s).
15. Perform steps 5 through 8 to the connector(s).
16. Reconnect the inboard and/or outboard connectors.
17. Enable the SIR system. Refer to the SIR Disabling and Enabling in SI.
18. Clear any sensing and diagnostic module (SDM) DTCs using a scan tool. Verify that the airbag indicator is NOT displayed on the instrument panel cluster (IPC). If DTCs appear after clearing the SDM, refer to the appropriate diagnostic information in SI.
