Bulletin No.: PI1359

Service Bulletin

Subject: Pop or Clunk Noise in Rear of Vehicle

Models: 2014-2015 Chevrolet Camaro
Built Between May 5, 2014 and September 26, 2014

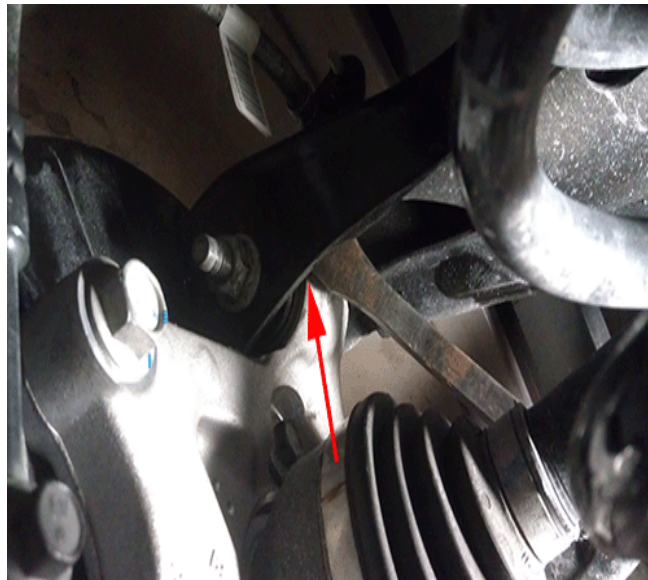
4007393

This condition may be caused by the upper control arm ball joint in the rear knuckle being loose.

1. With the vehicle on hoist, apply light pressure using a pry bar or equivalent to the rear of the upper link relative to knuckle to confirm the ball joint is loose.

2. If any movement above 1 mm (0.04 in) occurs from the rear knuckle ball joint, replace the affected rear knuckle. Refer to Knuckle Replacement in SI.
3. If there is no movement, continue with diagnosis. Refer to Noise Diagnosis Rear Suspension in SI.
