GM Bulletin No.: 14154

# Service Bulletin SB-10057075-6266

**SUBJECT:** Service Update for Inventory and Customer Vehicles

220 Amp Generator Fuse Block Corrosion

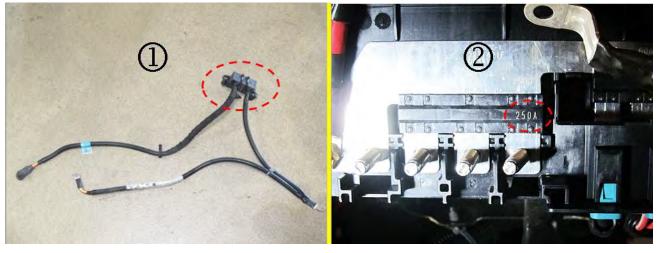
40094453

**Note:** With the new parts design, the 250 Amp fuse which was previously located on the cables (1) has now been re-located in the fuse battery distribution block (2).
