Service Bulletin

SB-10057079-2072

SUBJECT: Service Update for Inventory and Customer Vehicles
Rear Door Inside Handle Release Cable Misrouted
Expires with Base Warranty

MODELS: 2014-2015 Cadillac CTS Sedan (VIN A)

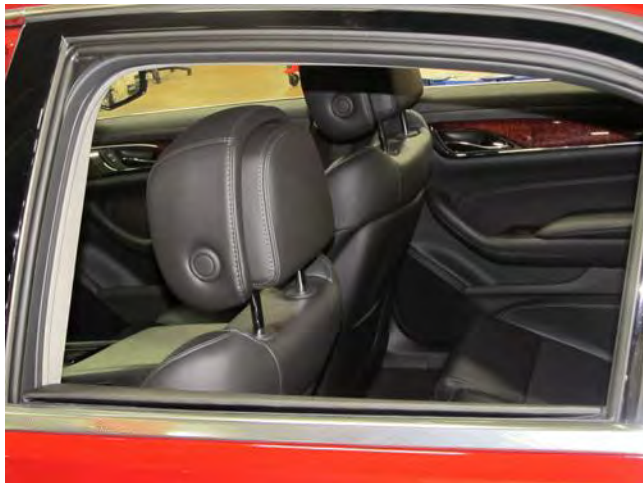
3997956

Fully open both left and right rear windows and inspect for full travel of the door glass down into the door.

- If the windows lower fully into both doors, no further action is necessary.

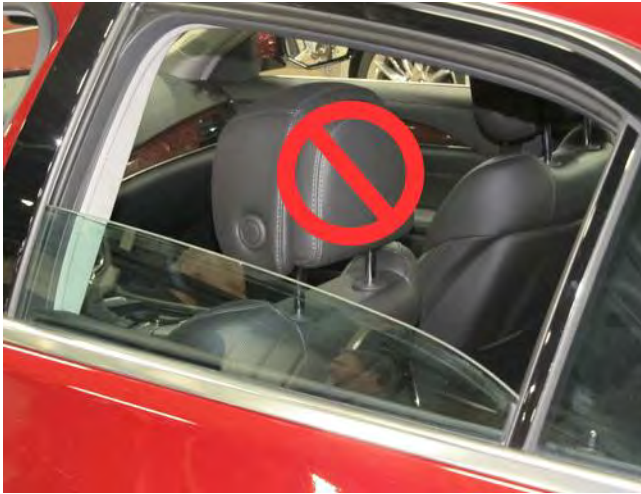
3997957

- If window travel is restricted on either rear side door, continue ahead to the *Repair Procedure*.

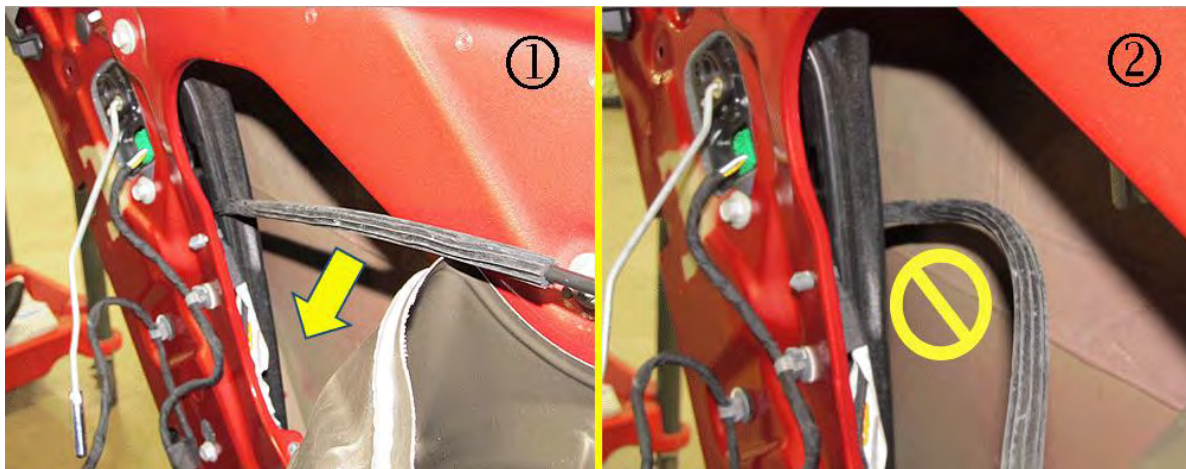
3997967

This bulletin provides a service procedure to inspect the glass travel on both rear doors on **certain** 2014-2015 model year Cadillac CTS sedan (VIN A) vehicles. These vehicles may have been built with a rear door inside handle release cable that is misrouted. A misrouted release cable could restrict the glass travel. An unlocked door with this condition will unlatch and open when an attempt is made to fully lower the window. Once unlatched, the door will not shut until the window is raised and there is an attempt to operate the inside release handle. A locked door with this condition will jam in a locked state when an attempt is made to fully lower the window. Once jammed, the door – even if unlocked - will not open from the outside until the window is raised and there is an attempt to operate the inside release handle.

Note: When installing the new rear side door inside handle cable, ensure proper routing of the cable within the door. As shown in the graphic above, the cable **MUST** be routed on the inboard side (1) of the vertical glass channel, **NOT** the outboard side (2).
