Bulletin No.: PIE0316A

Subject: Engineering Information – Battery Saver Active Message Displayed on DIC, Drive Motor Generator Belt Broken, DTC P1A6F or P0A90 May be Set

Models: 2013-2014 Buick LaCrosse, Regal
2013-2014 Chevrolet Malibu
Equipped with eAssist (RPO LUK)

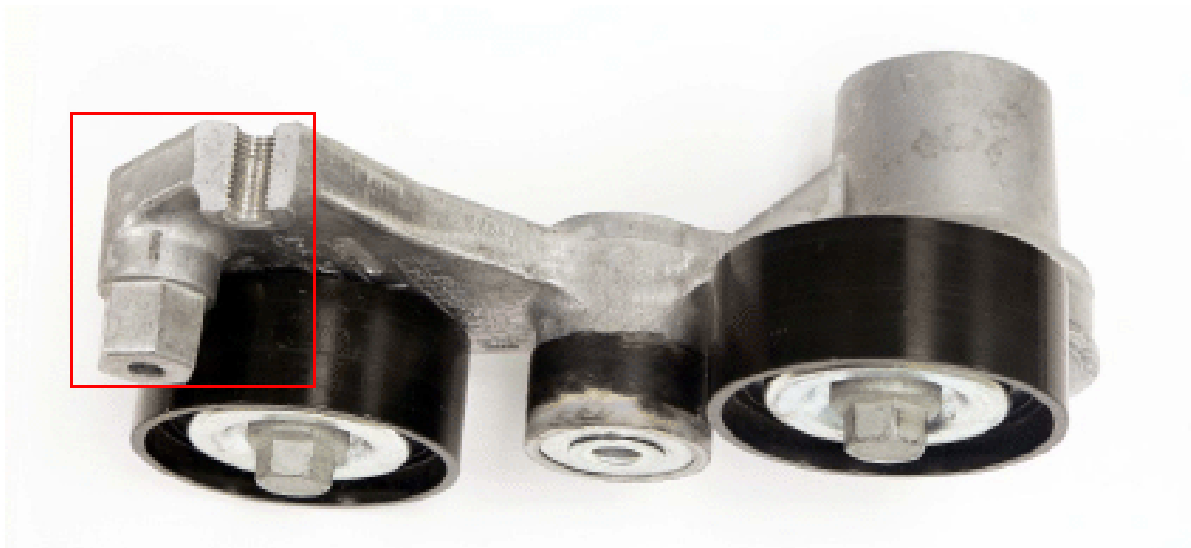
3973868

Further inspection may reveal that the drive motor generator unit (MGU) belt is broken or the tensioner is broken at the hydraulic tensioner attachment boss (shown below).

If you encounter a vehicle with the above concern, inspect the MGU belt and tensioner. If the belt looks like it was cleanly snapped or if the tensioner is broken at the attachment boss (shown below), contact the engineer listed below for further instructions.
