GROUP <b>ELE</b>	MODEL <b>2012~2013MY Rio (UB)</b>
	NUMBER <b>067</b>	DATE <b>October 2014</b>
<b>TECHNICAL SERVICE BULLETIN</b>		
SUBJECT: <b>IN PANEL MODULE (IPM) REPLACEMENT – DTC C1611</b>

**SUBJECT: IN PANEL MODULE (IPM) REPLACEMENT – DTC C1611**

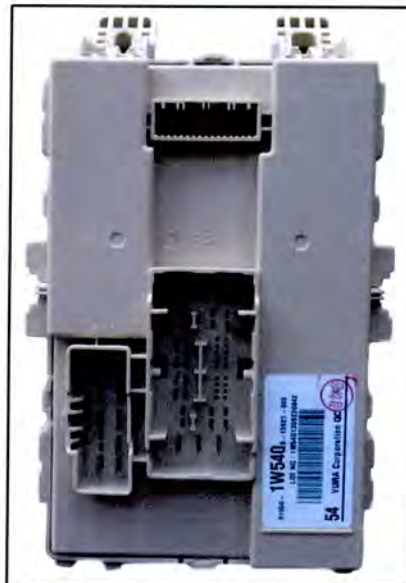
**DTC C1611 – MDPS CAN Communication Error to ECU**

This bulletin provides the procedure to replace the In-Panel Module (IPM) of some Rio (UB) vehicles produced from November 7, 2011 through October 30, 2012, which may experience a momentary decrease in power steering assist, at times accompanied by a flashing ESC lamp and DTC C1611(MDPS CAN communication Error to ECU). This condition typically will occur more often during start up/at idle, and in areas with low ambient temperatures, when intermittently poor contacts in specific IPM circuits may result in CAN communication errors. When this happens, DTC C1611 may be set and the power steering assist level will decrease. Although cycling the key will restore the power steering assist to the normal level, customers may complain of sometimes having to use a higher than normal amount of effort to steer the vehicle. To resolve the concern, replace the In-Panel Module (IPM) with an improved part by following the applicable service procedure on KGIS and by utilizing the information in this bulletin.
