GROUP TRA	MODEL ≥ 2011MY
	NUMBER 055	DATE October 2014
TECHNICAL SERVICE BULLETIN		
SUBJECT: INHIBITOR SWITCH DIAGNOSIS INFORMATION

**SUBJECT: INHIBITOR SWITCH DIAGNOSIS INFORMATION**
**Service Procedure:**

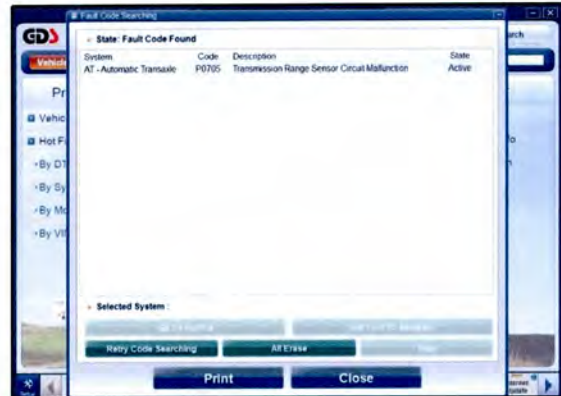
1. Connect GDS to the vehicle and perform a self-diagnosis.

- If no DTC(s) are found, proceed to step 2.
- If DTC P0705 or any other DTC(s) are found, delete the DTC and proceed to step 2.

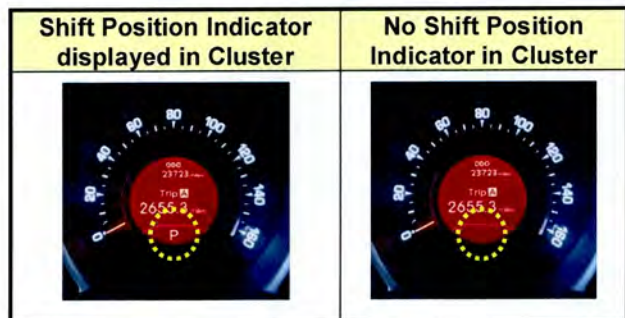
2. Place the shifter in Park ("P") and Neutral ('N') position and visually inspect the shift lever position indicator in the cluster.

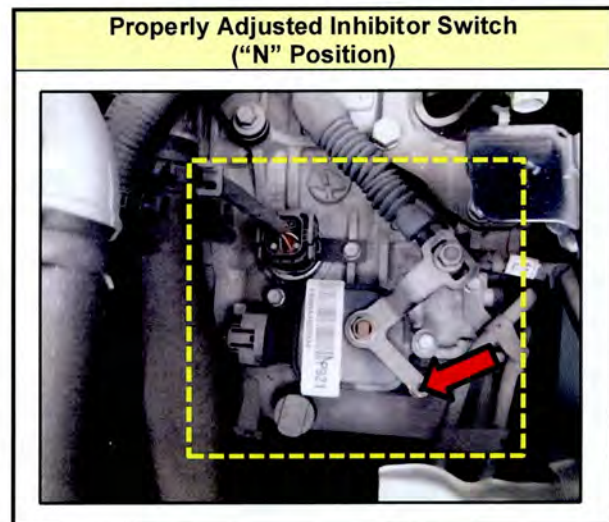
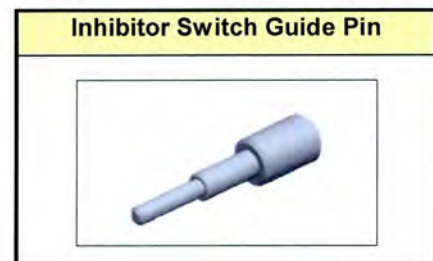
3. Place the shifter in Neutral ("N") and visually inspect the Inhibitor Switch for proper adjustment.

- If while in "N" position the inhibitor switch is properly adjusted, proceed to step 4.
- If while in "N" position the Inhibitor Switch is out of adjustment, refer to "Automatic Transaxle System > Automatic Transaxle Control System > Inhibitor Switch" chapter, in the applicable Workshop Manual, to adjust the Inhibitor Switch. Make sure to use the Inhibitor Switch Guide Pin (SST P/N 09480 A3800) while performing the Inhibitor switch adjustment procedure.
- If after adjusting the Inhibitor Switch the condition persists, proceed to step 5.

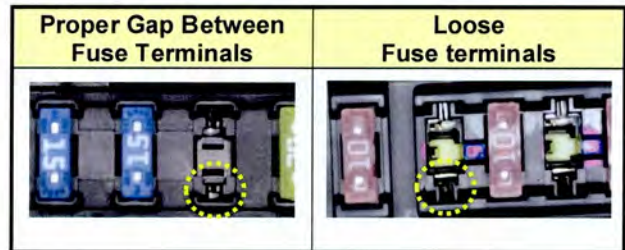
4. **Inhibitor Switch Connector and Fuse Block Inspection Items**

- Check the connector for foreign matter intrusion.
- Check the Fuse Block for loose fuse terminals.

Correct or repair as required.

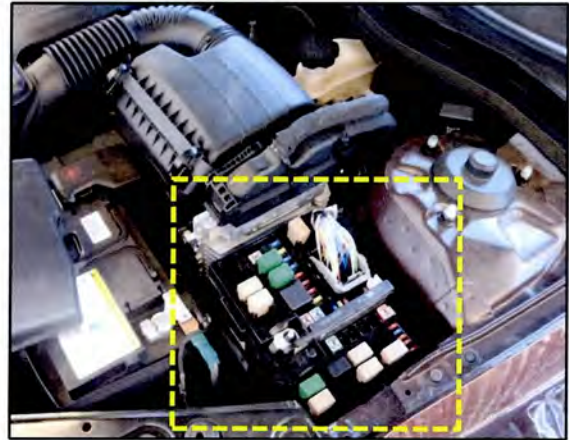
5. Locate the Junction Box in the engine compartment and check the TCU2 fuse and the Inhibitor Switch connector.

- Check the fuse capacity
- Check for a burned-out fuse
- Check the fuse holder
- Check for pinched wires, foreign matter intrusion and for bent pins in the connector.

Correct or repair as required.

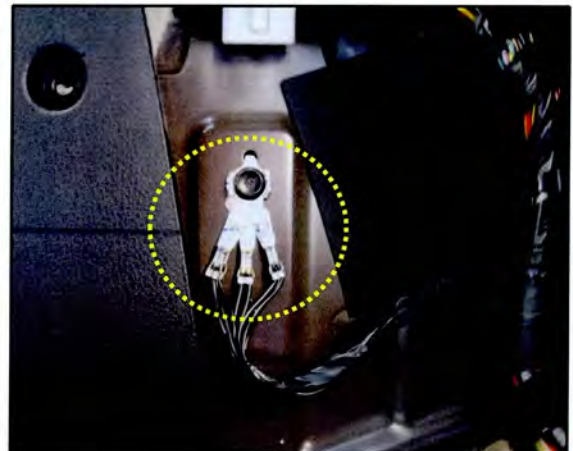
6. Check the rear combination lamp harness for a proper ground.

If the rear combination lamp is properly grounded, replace the inhibitor switch. If not, check/clean ground and tighten the bolt.
