Service Bulletin

Subject: ROUGH IDLE WITH MIL ON AND DTC P0015 / P0524	Bulletin No: 01-009/14
	Last Issued: 09/03/2014

Subject: CRACKING NOISE FROM WINDSHIELD AND/OR REAR WINDOW	Bulletin No: 09-025/14
	Last Issued: 09/03/2014

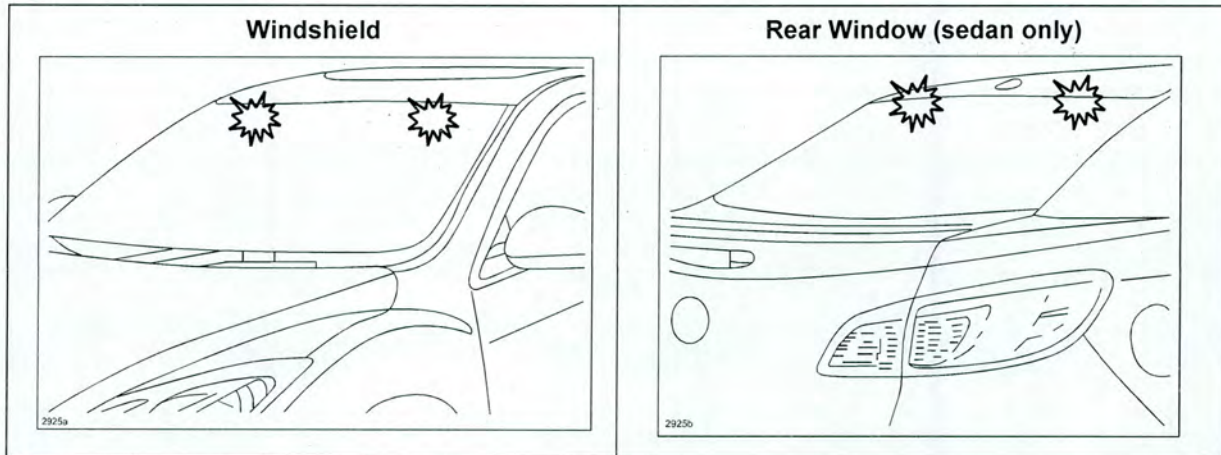
Some vehicles may exhibit a cracking noise originated at the positioning pins near the top corners of the windshield and/or rear window when driving on uneven road surface. This happens when the ambient temperature is approximately 14 °F (-10 °C) or lower and the vehicle cabin has not yet warmed up. The noise is caused by the windshield and/or rear window locating stopper contacting the panel.
