Service Campaign Bulletin

SB-10057108-9938

Campaign No. 2014090005, October 2014

SUBJECT: **Model 197 (SLS-Class), Model Year 2014**
Check Upper Engine Bracket, Replace if Necessary

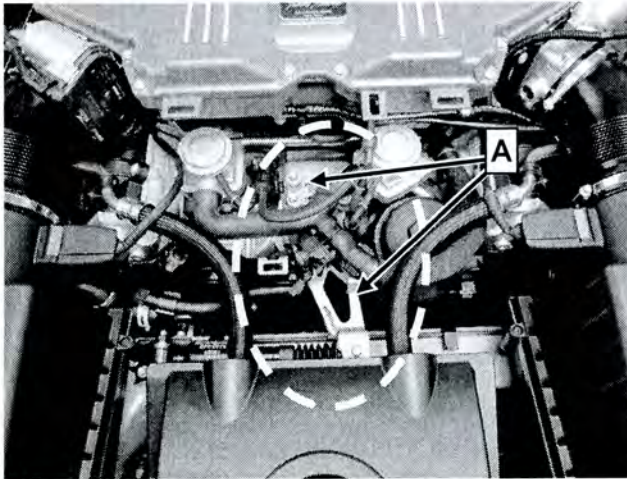
Figure 2

This Service Campaign has been initiated because Daimler AG (DAG), the manufacturer of Mercedes-Benz vehicles, has determined that the upper engine bracket does not meet current specifications and may contribute to increased noise in the engine compartment. To correct this condition an authorized Mercedes-Benz dealer will check, and if necessary, replace the upper engine bracket at the next dealer visit.

Check if bracket installed on engine (A, Figure 2) is silver:
 - If a **silver** bracket is **installed** on the engine (OK): Procedure is complete.
 - If a **black** bracket is **installed** on the engine (NOT OK): Continue with Procedure.
