Service Campaign Bulletin

SB-10057109-4627

Campaign No. 2014090006, October 2014

SUBJECT: **Model 197 (SLS-Class), Model Year 2014**
Check Power Steering Line Spacing, Correct if Necessary

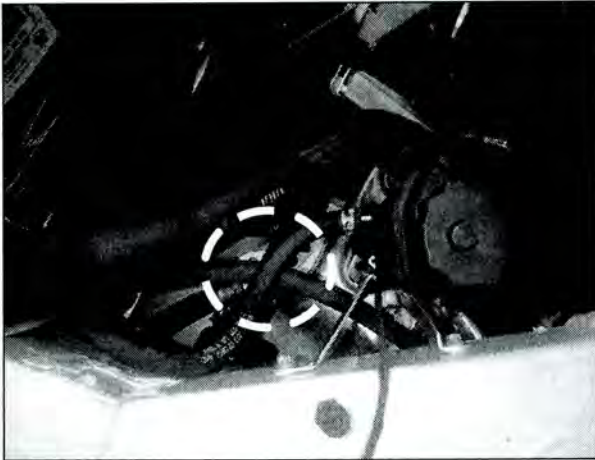
Figure 1

Check minimum distance and condition of power steering lines (Figure 1):

- If minimum distance is at least 10 mm and line is **not** damaged (OK): Procedure is complete.
- If Minimum distance is **not** at least 10 mm (NOT OK) and line is **not** damaged (line OK): Proceed to step 3.
- If minimum distance is **not** at least 10 mm (NOT OK) and the line **is** damaged (line NOT OK): Proceed to: Steps 2 and 3.

Replace damaged power steering lines; refer to WIS: AR46.25-P-3015RQ.
