Supplemental restraint system (SRS) lamp in instrument cluster lights up; fault code B000213 and/or B000113 is logged in the SRS control unit

| Topic number | LI91.60-P-058226 |
| Design group | 91.60 Airbag, pedestrian protection |

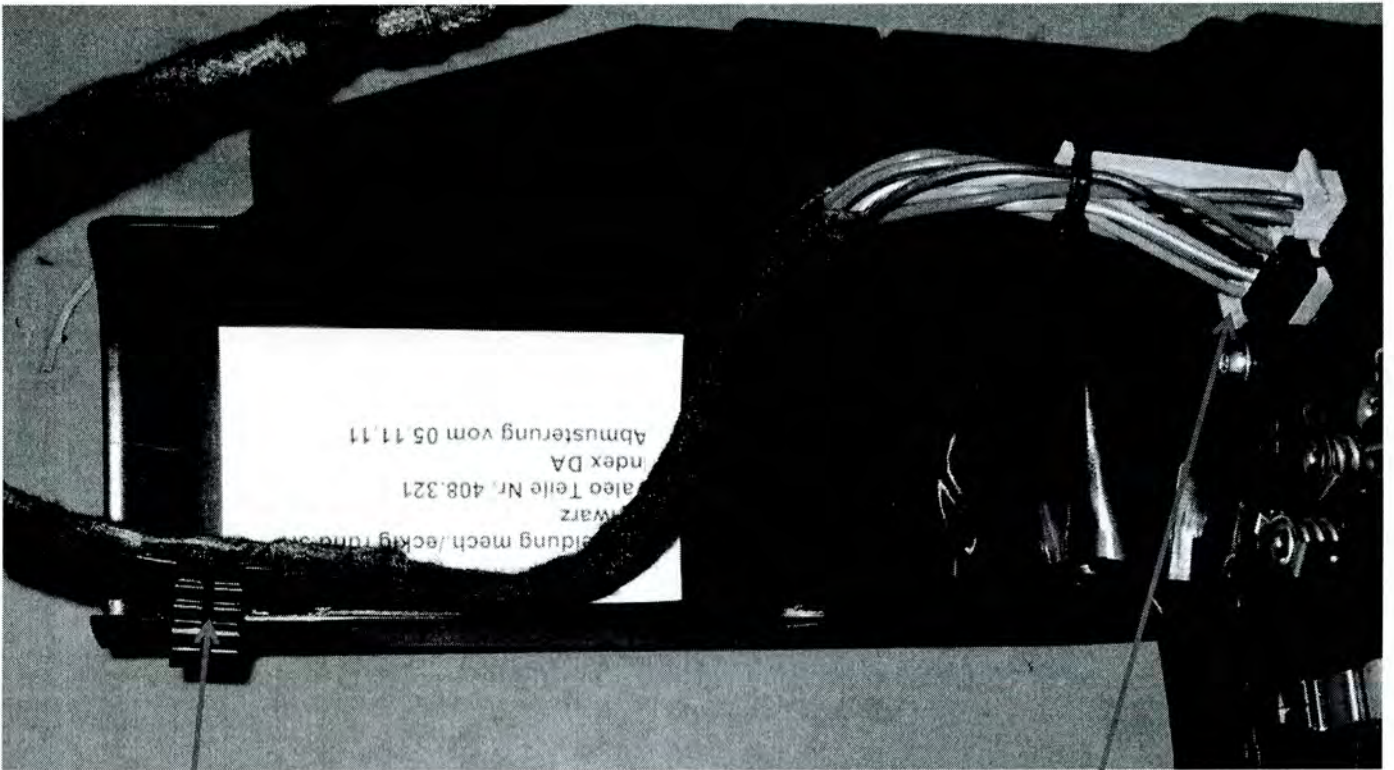
| Attachments | |
|---|---|
| Anhang 1.pdf | Position of connector and edge clip |

Contact between interior wiring harness and steering column tube switch module (steering column tube switch module connector no.1), see attachment 1, item "1"

2.) Check that the edge clip is correctly positioned and firmly locked (see attachment 1, item "2").

If the actual values are OK -> Replace the contacts between the interior wiring harness and the steering column tube switch module (attachment 1, item "1"):
