WARRANTY BULLETIN

CAN-AM® ROADSTER

Campaign no.: 2014-0010

Subject: **A - Fast Flasher Blink Rate**

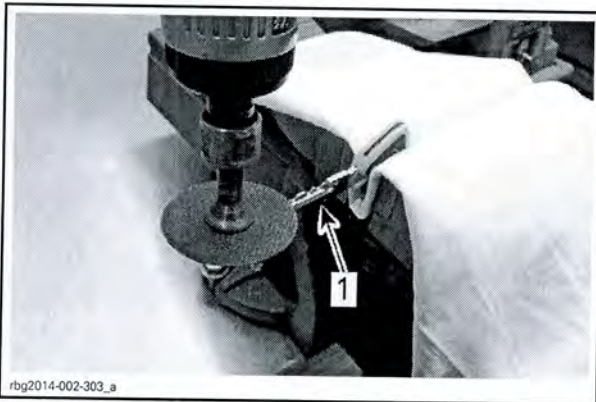
1. Key held in vise

1. Secure ignition key in a vise as illustrated.

NOTICE Do not overly tighten vise or damage to the key will occur.

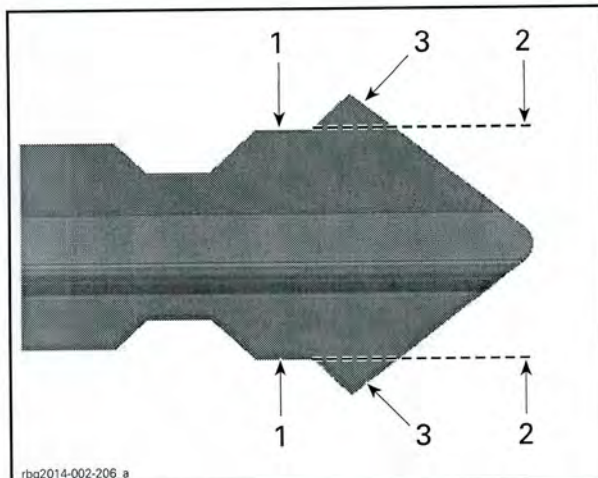
1. Reference flat surface
2. Cut line
3. Material to remove

2. Using a small rotary tool, grind off the last point on both sides of the end of the key.

NOTE: The height of the last flat surface will vary with the key code. The modified surface must be in line with and square to the last flat surface of the key.

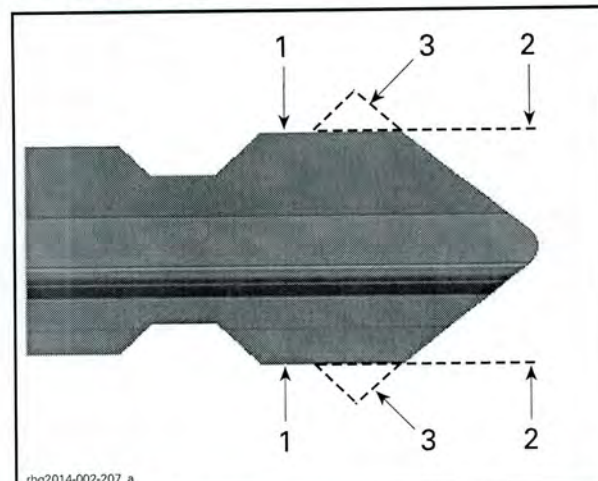
1. Reference flat surface
2. Cut line
3. Material removed

3. Ensure key functions properly:
- Key ON/OFF
 - Seat unlock
 - Front storage compartment unlock
 - Rear cargo compartments unlock (RT model).
