# Technical BULLETIN

## Certain 2013 FJR1300A MODELS Fault Code 14 with Change in Altitude

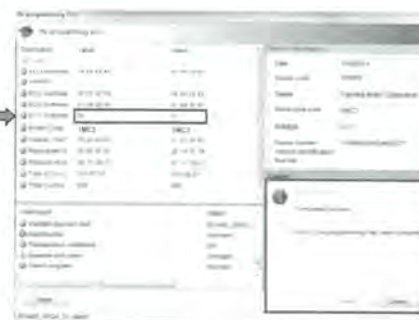
NOTE: IF THE ECU SOFTWARE IS STOCK, THEN THE UNIT HAS THE ORIGINAL PROGRAMMING IN THE ECU SOFTWARE AND WILL SHOW 00 ON THE LEFT PANE. AFTER THE ECU IS REPROGRAMMED, THE NUMBER WILL CHANGE TO 01.

8. Enter the malfunction feature of YDT and clear the codes. Code 50 will be stored (ECU internal malfunction) due to the reprogramming. Now, exit the application and disconnect YDT from the unit.
