Vehicle Speed Sensor  
CHU, CXU, GU, TD

## FSB 386-007, Vehicle Speed Sensor

(November 2014)

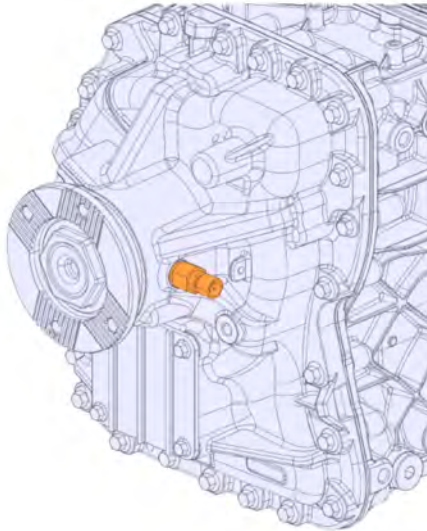
W3094986

- 4 Remove the VSS from the transmission.

**Note:** If a gasket or shim is present between the sensor and transmission discard it **DO NOT** reuse with new sensor.

**Note:** If sensor part number 3171490 is found to have been installed and needs to be replaced, this sensor is also replaced with 22387296.
