Field Service Bulletin

Cab Harness Insulation, Installation CHU, CXU, GU, TD

FSB 371-048, Cab Harness Insulation, Installation

(October 2014)

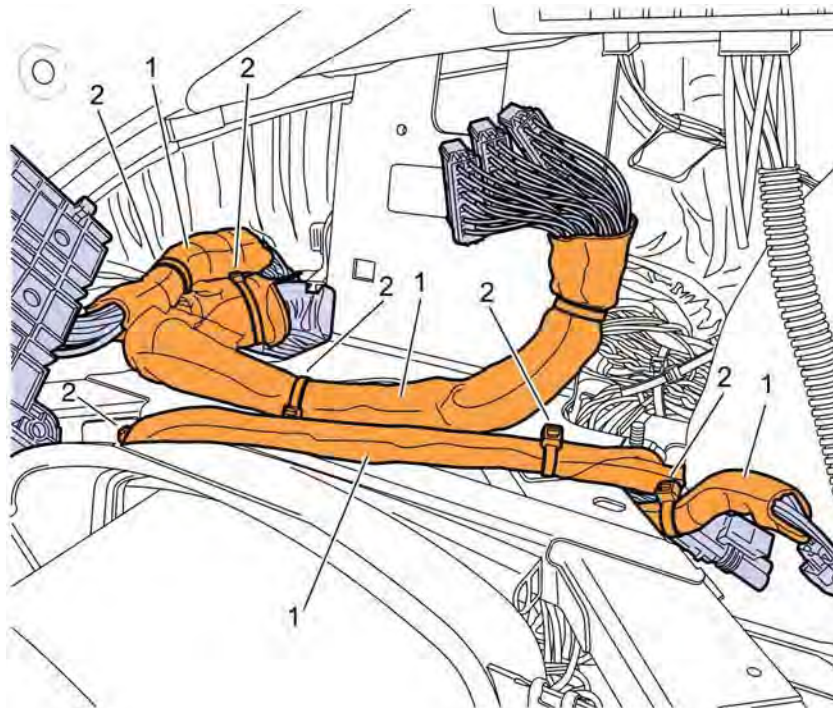
W3093293

In some MACK CXU, CHU, GU, and TD trucks built between 01/01/2007 and 10/03/2014, the cab wiring harness may experience chafing in or around the steering column bracket. A self-wrapping insulation kit has been introduced to protect the cab wiring harness from chafing. The kit contains sections of insulation in 50 mm (2.0 in), 25 mm (1.0 in), and 13 mm (.5 in) diameter sizes. The insulation can be cut to desired lengths and wrapped around the harness areas in contact with the steering column bracket. Each section of insulation is secured using cable ties as needed.
