## Vehicle Speed Sensor VN, VAH, VHD

### FSB 386-007, Vehicle Speed Sensor

(November 2014)

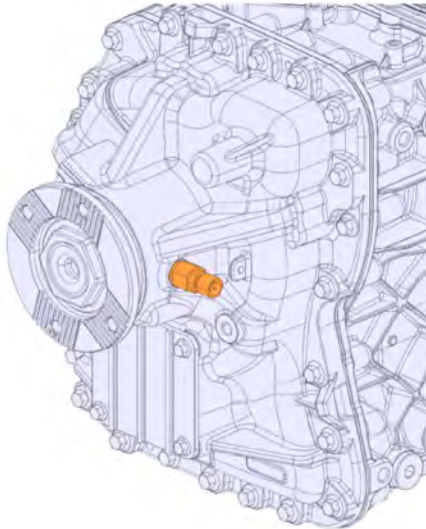
W3094986

On certain Volvo Trucks built from 8/20/2012 to 11/07/2014 with the I-Shift transmission, the vehicle speed sensor (VSS) may fail internally. This is due to a manufacturing defect of the sensor. This failure may cause fault codes related to road speed. This failure can cause multiple SPN 84 FMI 19 faults, both active and inactive, to occur and may cause the MIL light to come on in the dash.

- 4 Remove the VSS from the transmission.

**Note:** If sensor part number 3171490 is found to have been installed and needs to be replaced, this sensor is also replaced with 22387296.

**Note:** If a gasket or shim is present between the sensor and transmission discard it  
**DO NOT** reuse with new sensor.
